**CHAMPIA**  
REAL ESTATE INSPECTIONS

## Inspection Report

<b>Date:</b> 8/6/2018	<b>Time:</b> 09:00:00 AM	<b>Report ID:</b> 32621 a
<b>Property:</b> [Redacted]	<b>Customer:</b> [Redacted]	<b>Real Estate Professional:</b> [Redacted]

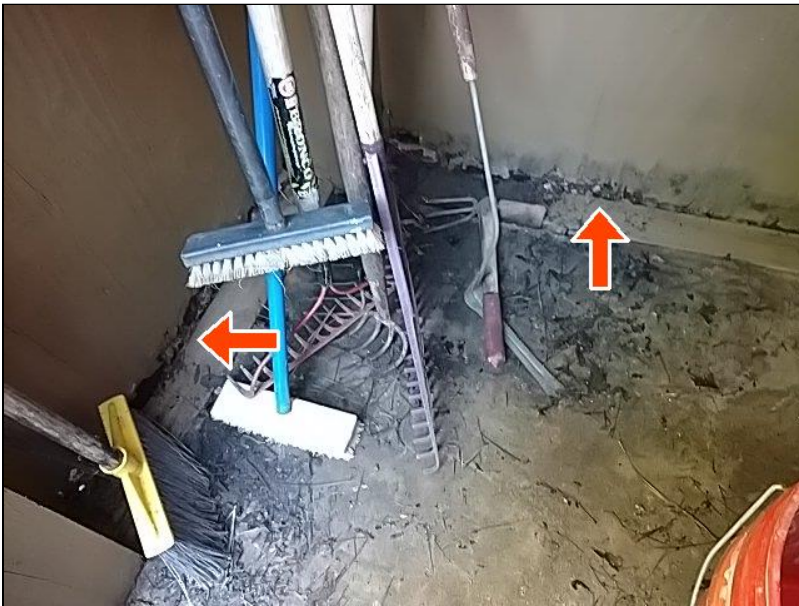
1.2 (1) Damage/decay noted at walls of the shed below the deck landing. Repair/replace as necessary.

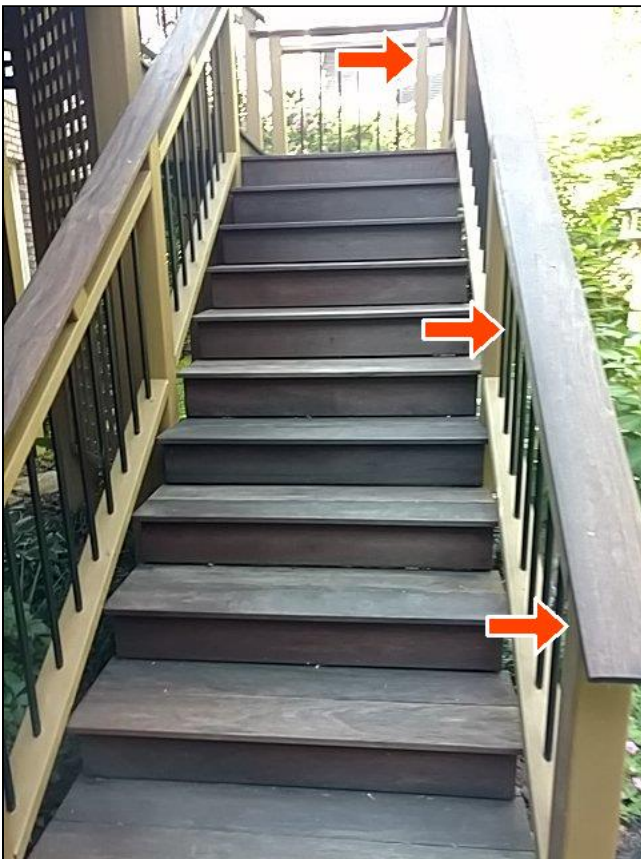
1.2 (2) Handrail not graspable at rear deck stairs. NOTE: Handrails should be graspable. Install as necessary.

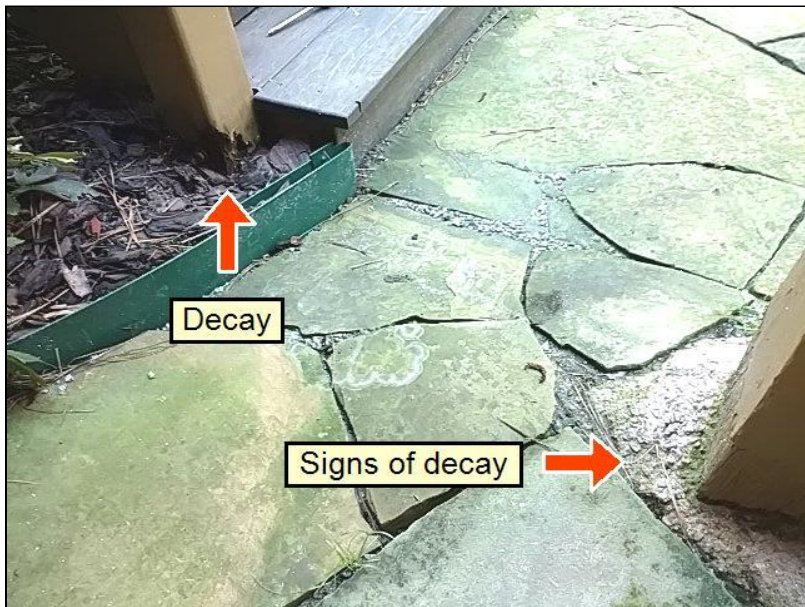
Rear deck stairs and post

1.2 (3) Decay noted at lower left deck stair post and signs of decay at rear support post(s). NOTE: Infestation of wood destroying organisms and decay is possible. Monitor and repair as necessary. Recommend to use ground-contact rated materials.

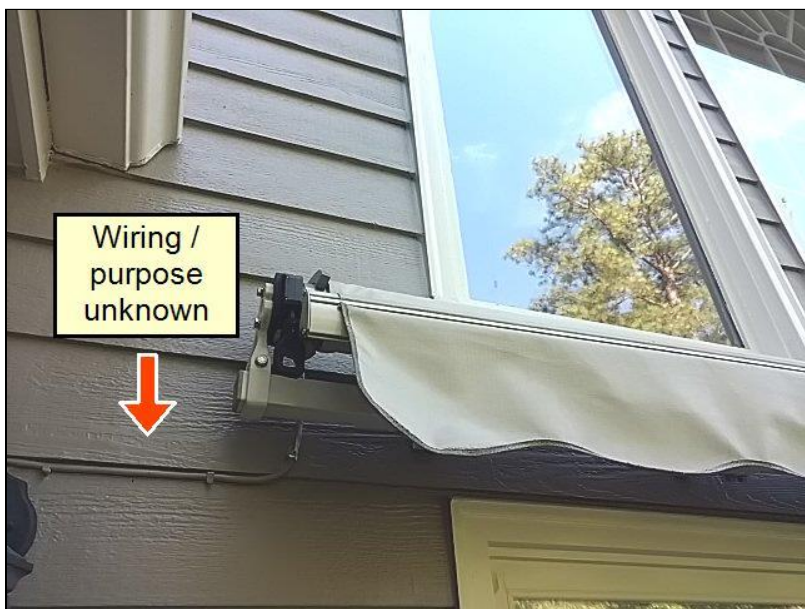
Rear deck

1.2 (4) Retractable awning noted at rear deck. NOTE: The awning attached to the electrical system, but the mechanism had to be operated manually to work. Recommend to consult with owner/refer to (awning) manufacturers guidelines for operational instructions.

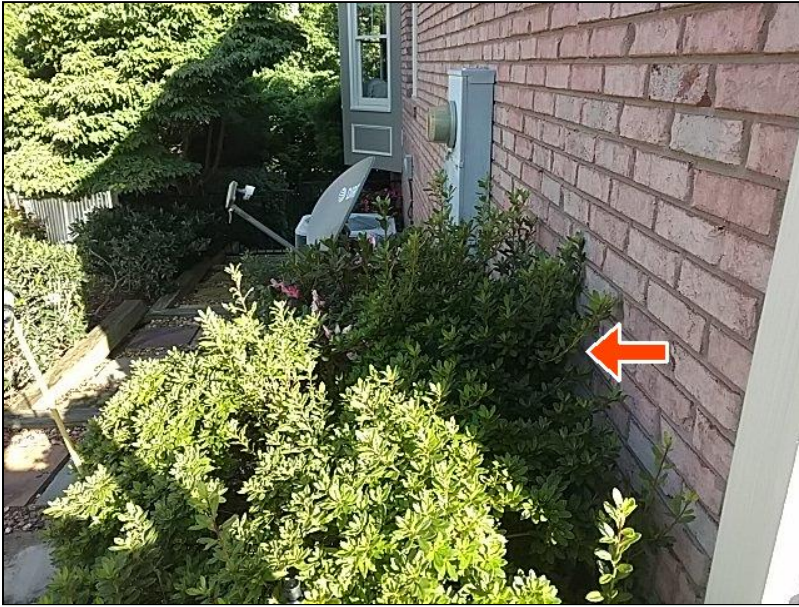
Front left

1.3 (1) Shrubs against the exterior noted front left and right. Recommend to maintain a distance of 6" to avoid damage to the exterior, animal and moisture entry.

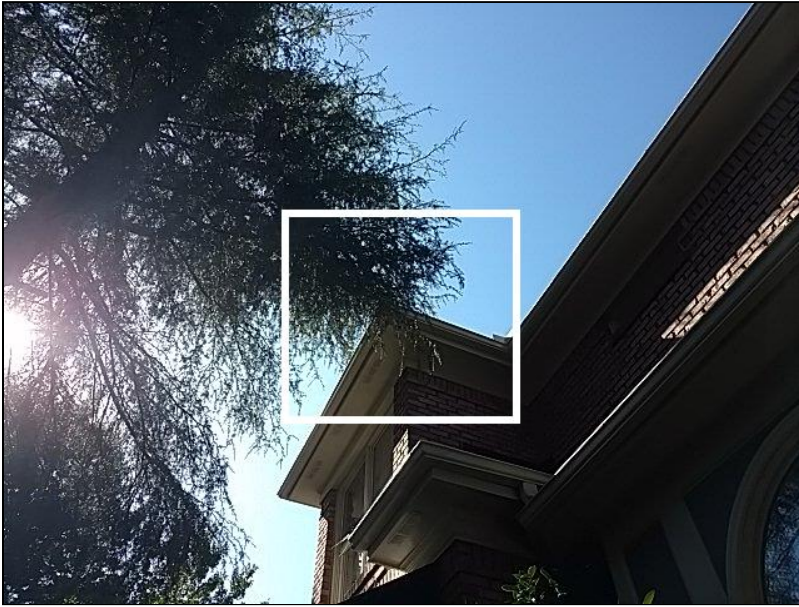
Right

1.3 (2) Overhanging branches noted at right. Remove/trim trees/branches as necessary to avoid hazard to occupants, damage to the roof and exterior.

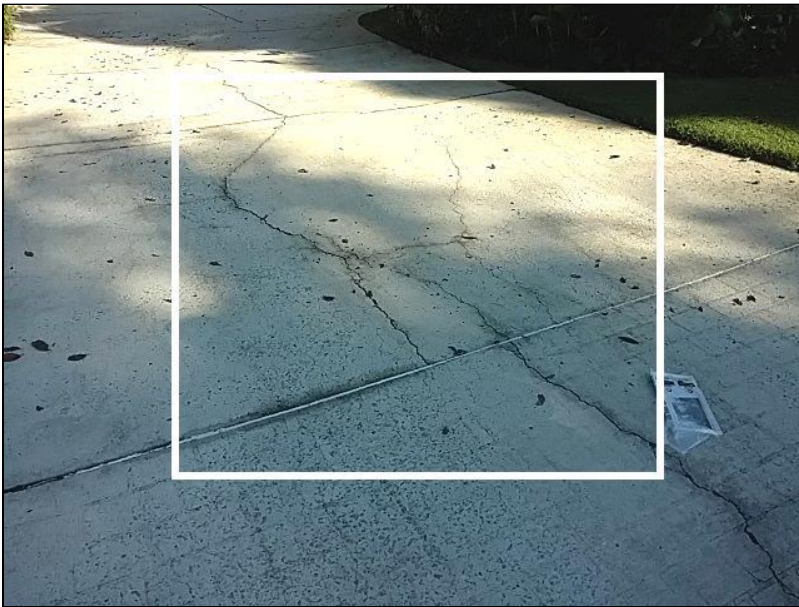
1.4 (1) Common cracks noted at driveway. Monitor and repair as necessary.

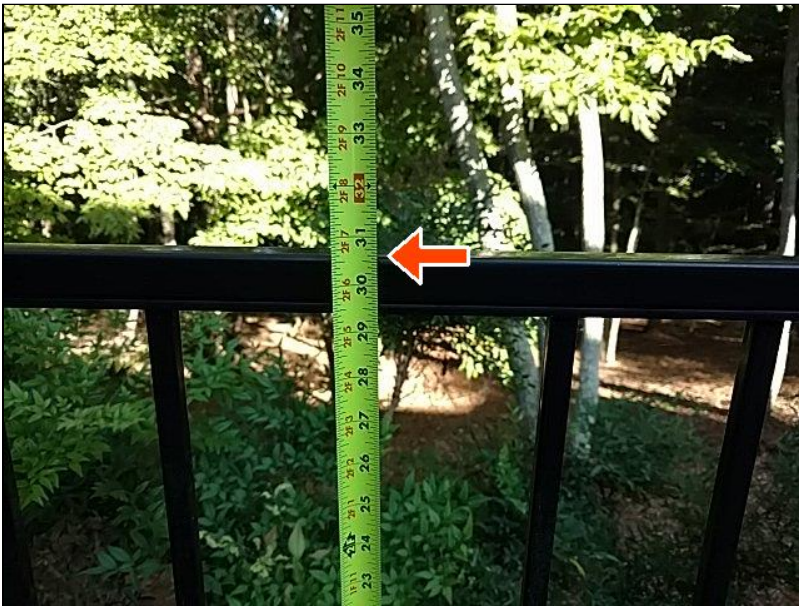
Rear left

1.4 (2) Railing to low at rear left guardrail. NOTE: Railings should be at least 36" high. Recommend upgrade.

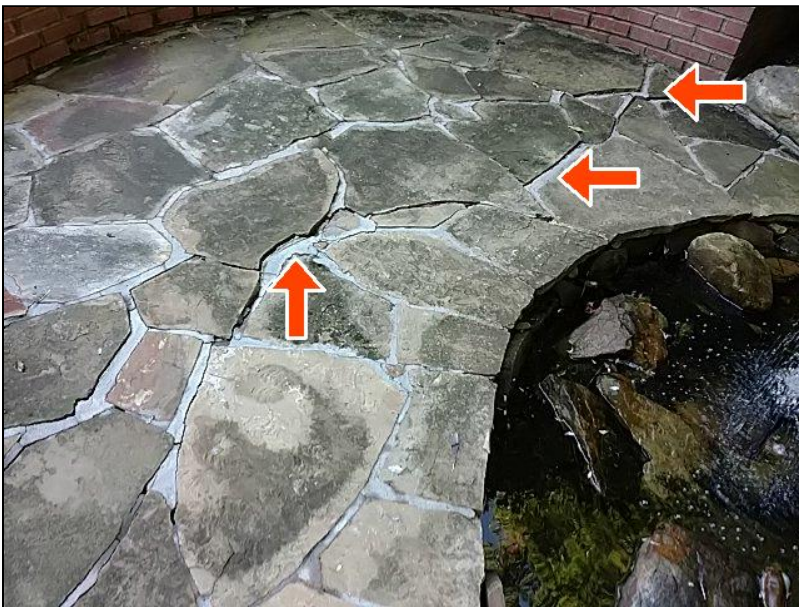
Rear left patio

1.4 (3) Settlement/displacement (appr. 1") noted at rear left patio. Repair as necessary.

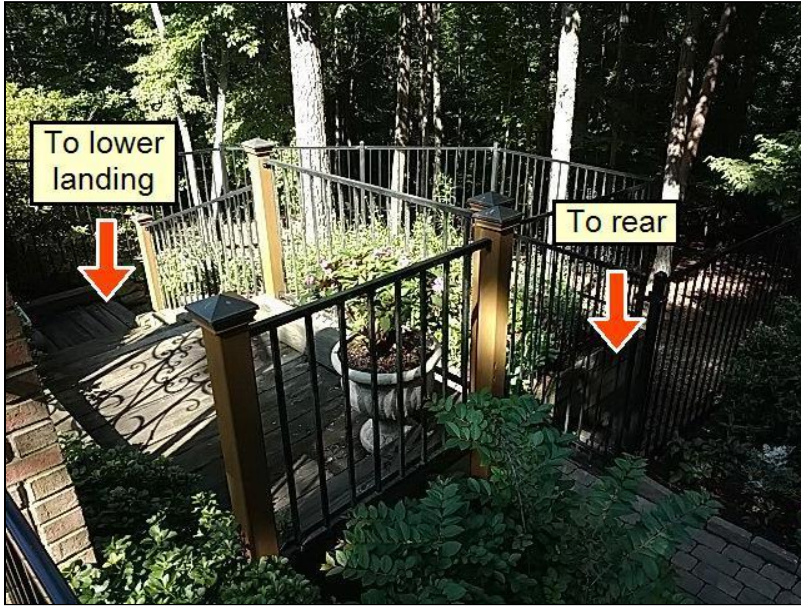
Rear

1.4 (4) Missing handrail noted at rear walkways/stairs to lower landing and rear of the property. Recommend to install handrails to increase operational safety.

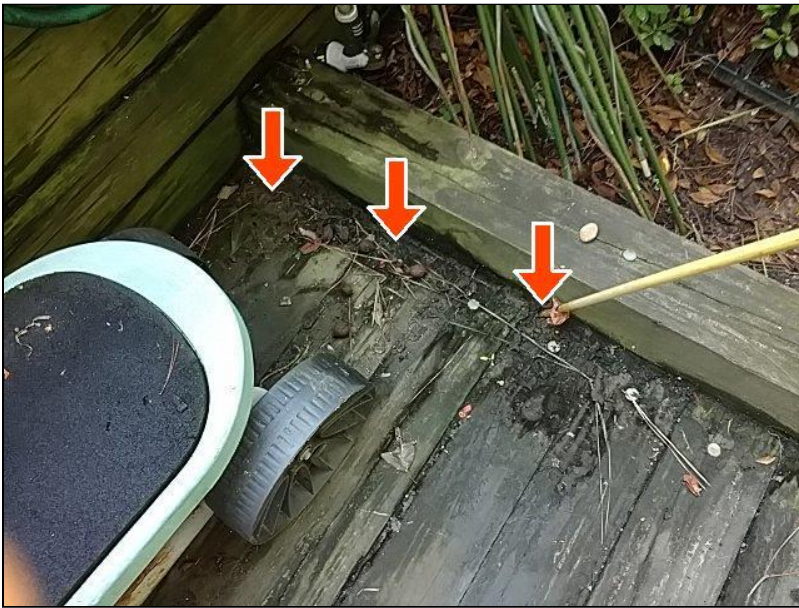
Rear lower landing

1.4 (5) Decay noted at rear lower landing timbers. Monitor and repair/replace as necessary.

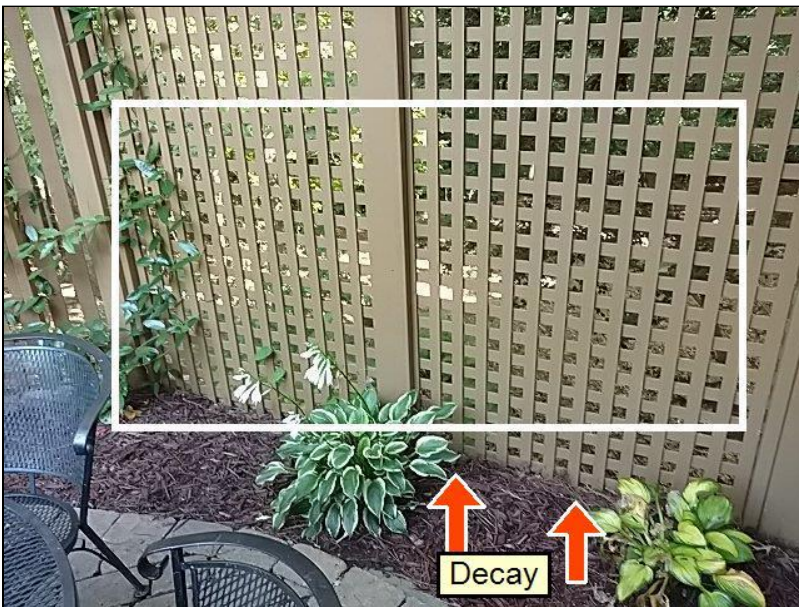
Lower patio.

1.4 (6) Insufficient guard noted at lower patio and signs on decay at the bottom of the material. NOTE: Guards should be able to withstand a side impact of 200 lbs. Recommend to upgrade guards.

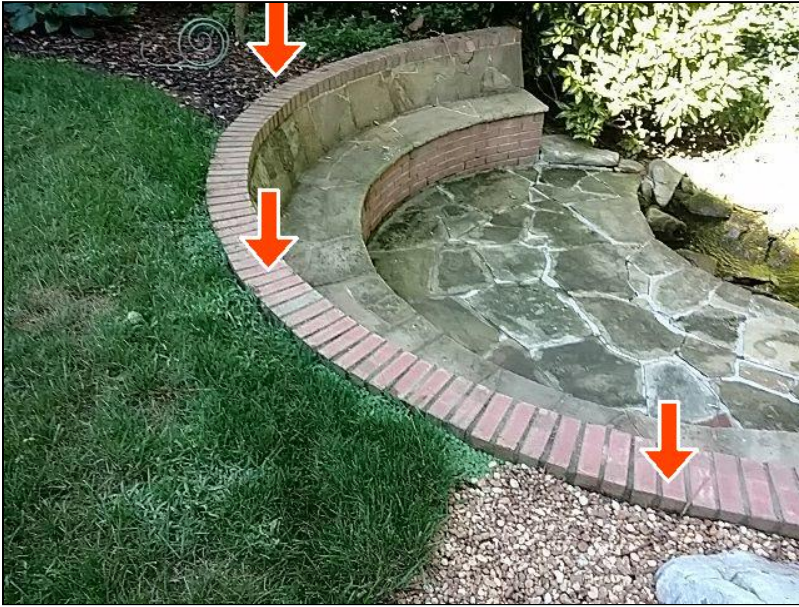
1.4 (7) Missing guards noted at rear left sunken bench. NOTE: Guards should be installed at distances at (or lower) than 30" within 3 ft. Recommend upgrade.

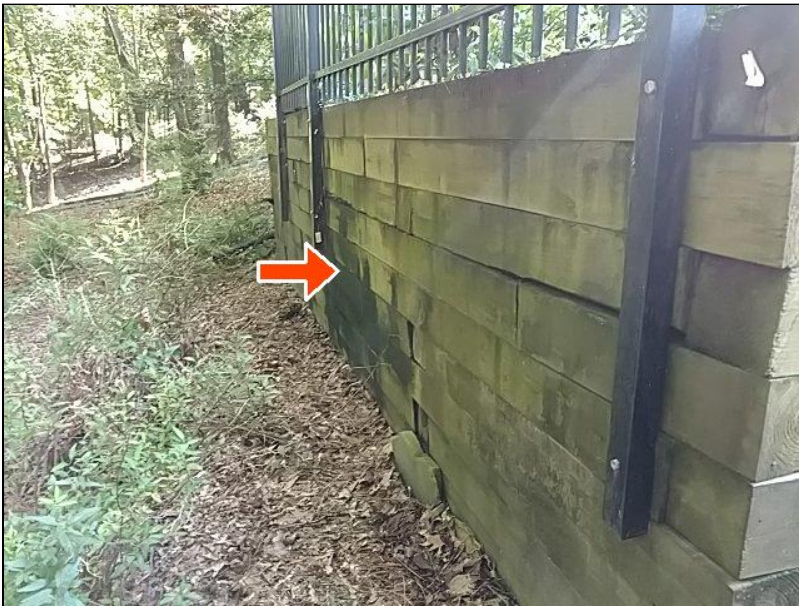
Rear right

1.6 (1) Slight bulge (appr. 1") noted at rear right retaining wall. Monitor and repair as necessary.

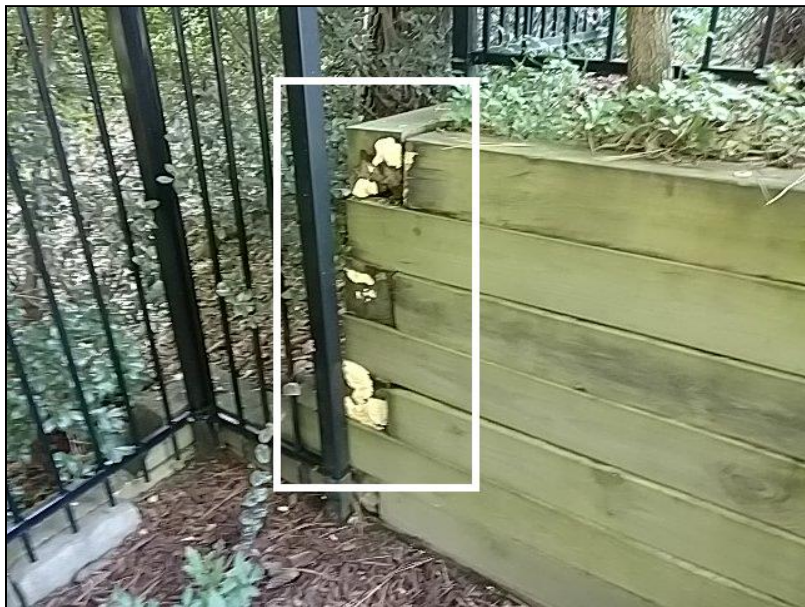
Rear right

1.6 (2) Signs of moisture exposure (as indicated by fungi growth) noted at rear right retaining wall material. Recommend to evaluate efficiency of drainage and adjustments/repairs as necessary.

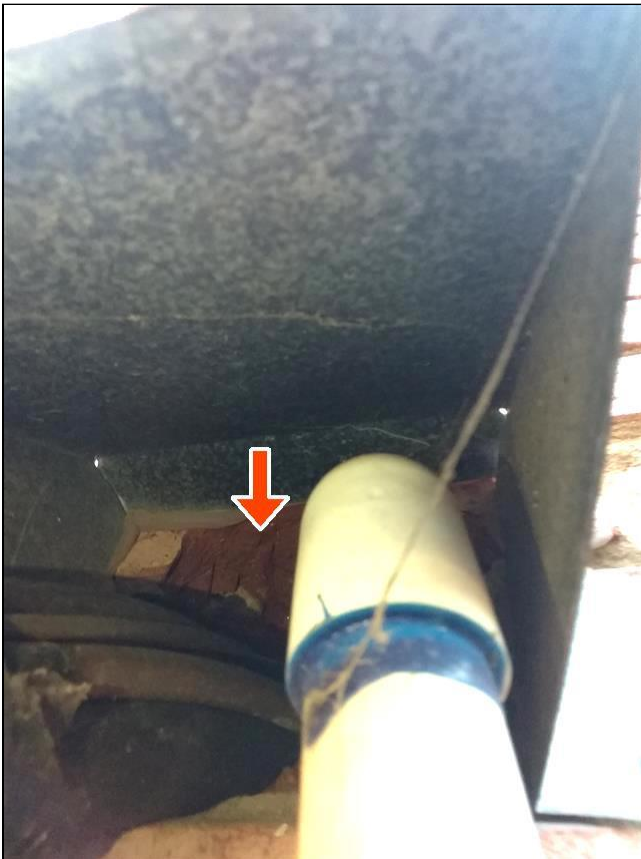
Wall penetration at left

**2.0 (1)** Unsealed penetration noted at exterior cladding at left side. Observed at/around condenser line sets penetrations. Seal penetrations to avoid moisture and animal entry.

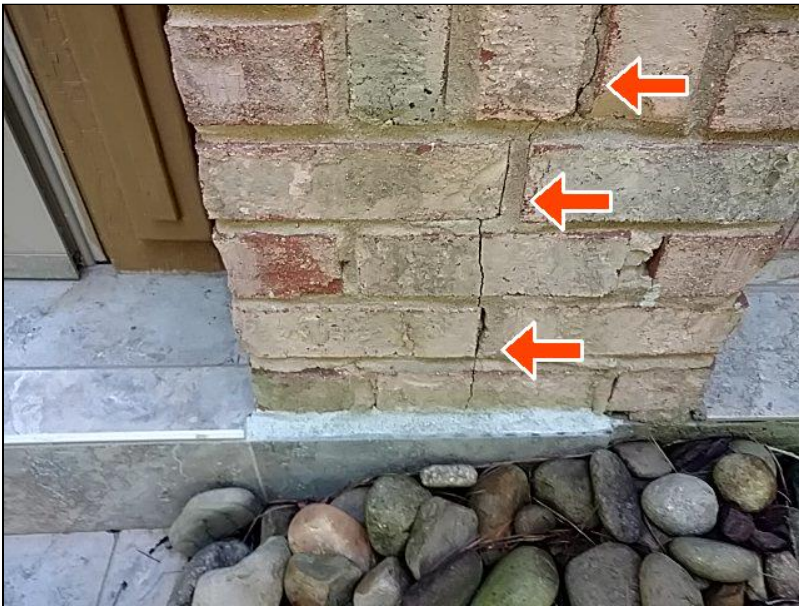
Rear right

2.0 (2) Crack noted at rear brick column. Monitor and repair/replace as necessary.

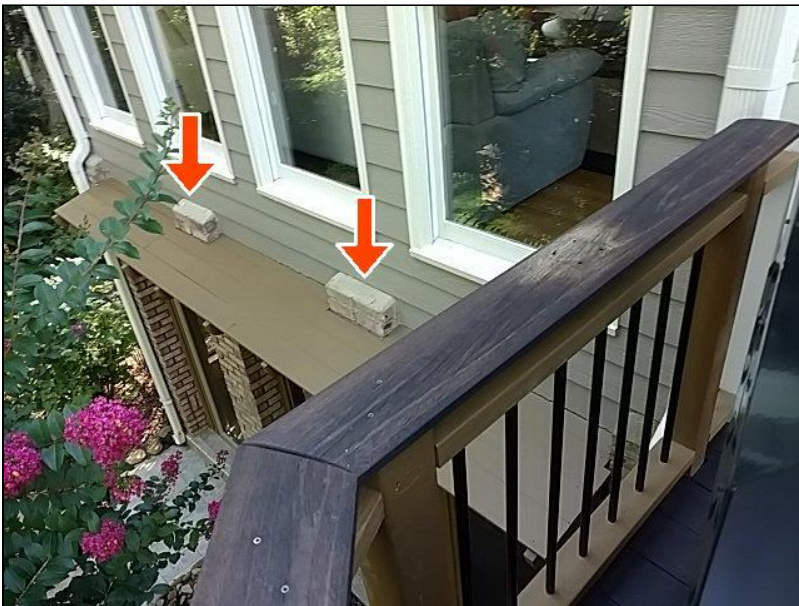
Rear right columns

2.1 (1) NOTE: Brick veneer and decorative roof at rear right sun room/porch appear to be added at a later date than original construction. The brick veneer (presumably around support columns) covers some of the fiber cement cladding and the columns are capped with masonry material. Flashing or sealant was not observed. Recommend to install flashing avoid moisture entry.

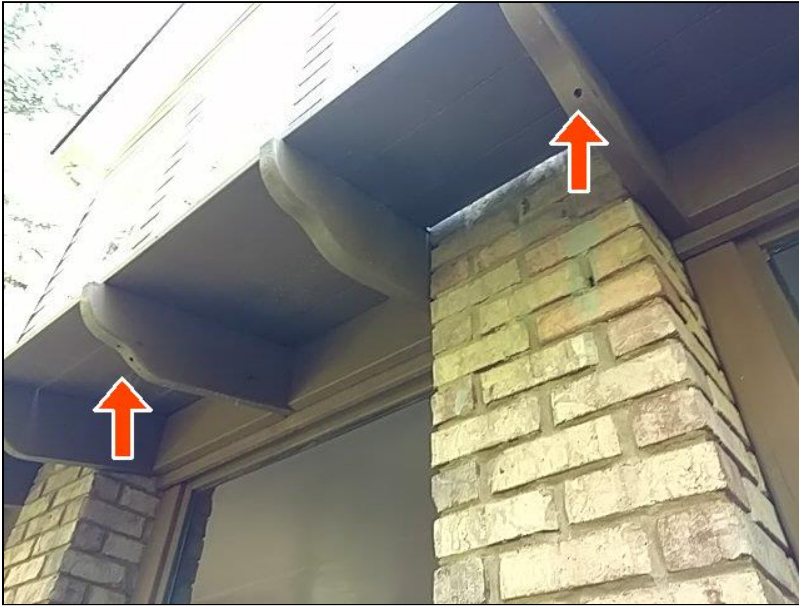
Rear right portico/roof

2.1 (2) Signs of activity of wood destroying insects noted at rear right and lower patio portico structures. Repair as necessary.

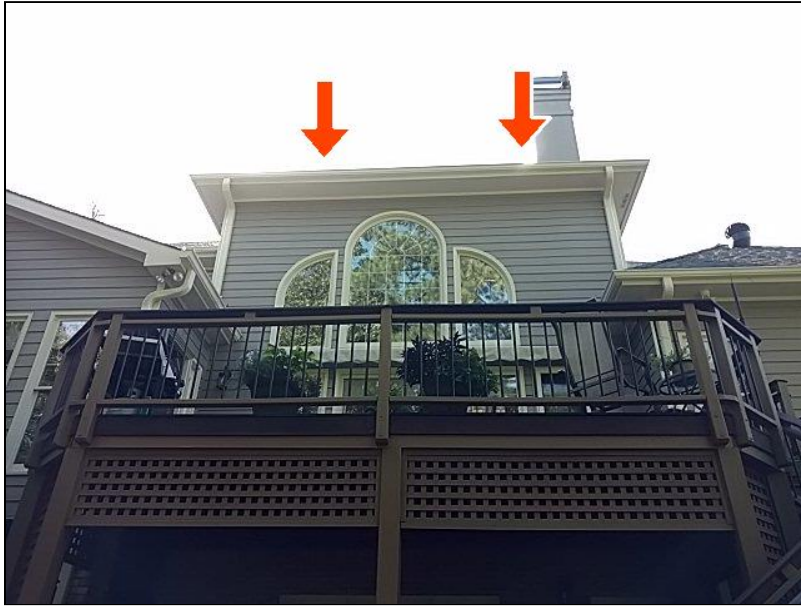
Rear

3.0 Roof at rear and right was not visible due to lot and height restrictions. Unable to inspect. Recommend to consult with a licensed roofing contractor for evaluation.

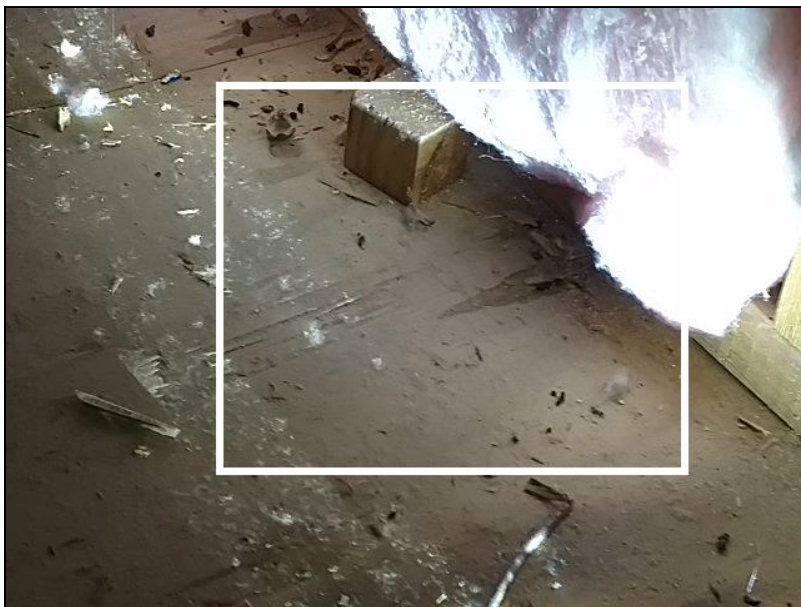
Attic, left

3.5 Signs of animal activity noted in the attic (droppings). Recommend to consult with a qualified pest and wildlife exclusion contractor.

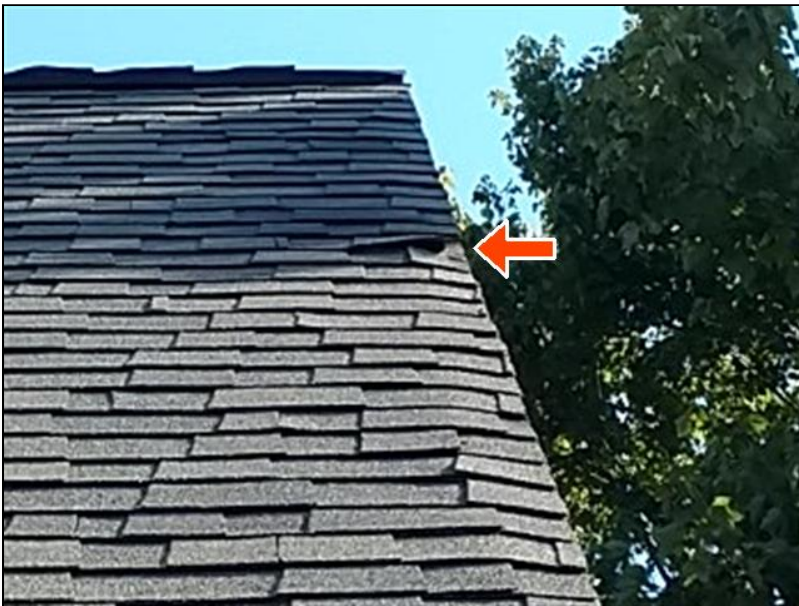
Front right

3.6 (1) Lifted shingle noted at front right gable. Recommend adjustments to lay shingle(s) flat and minimize risk of wind damage.

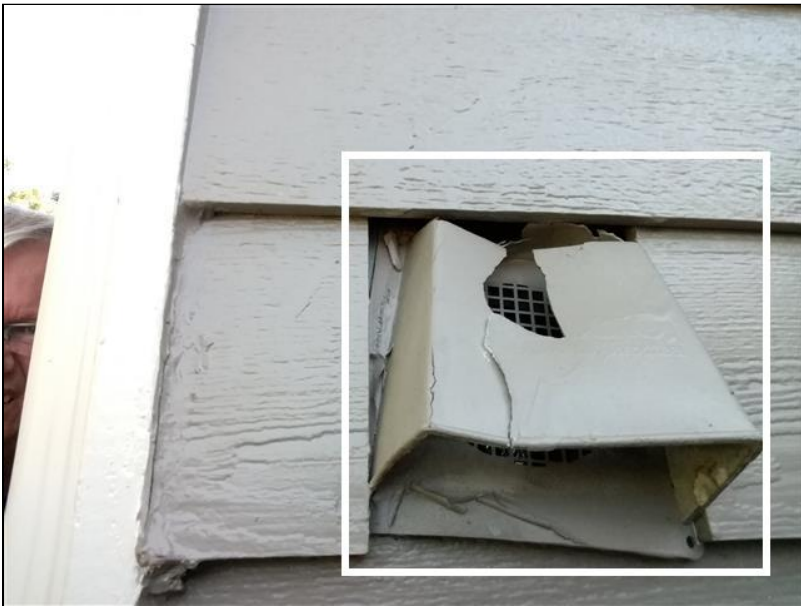
Rear left

3.6 (2) Damaged vent cover noted at rear left roof area. Replace cover.

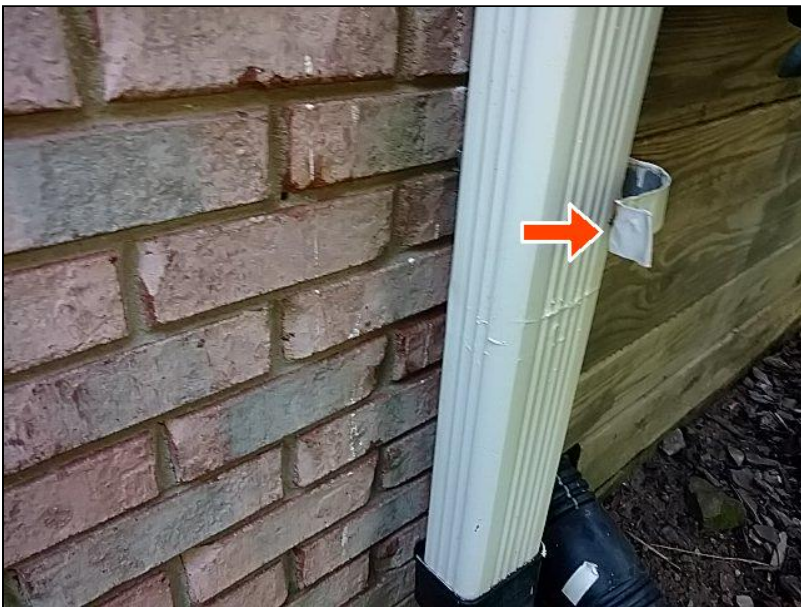
Rear left

3.9 (1) Loose downspouts noted at rear left, right and center. Repair as necessary.

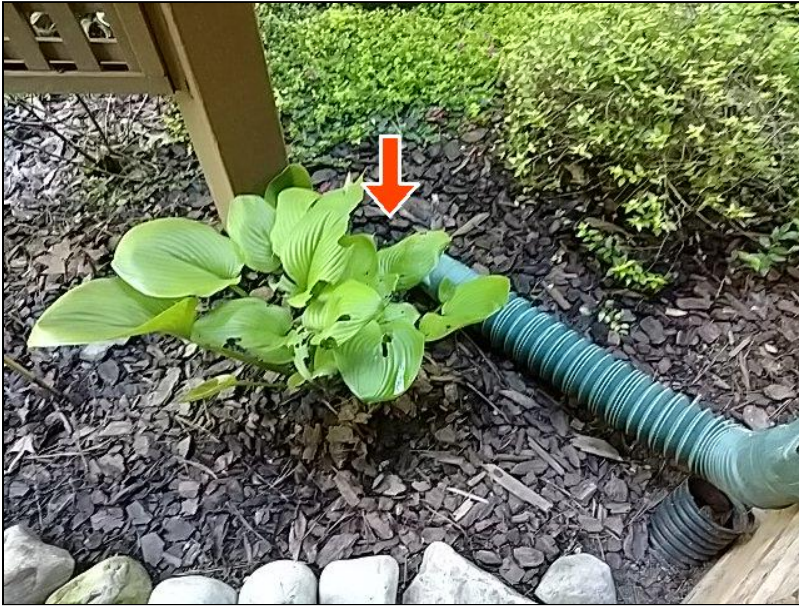
Rear center

3.9 (2) Downspout extension at rear center terminated in front of deck support column. Recommend to re-direct extension to avoid erosion/weakening of soil.

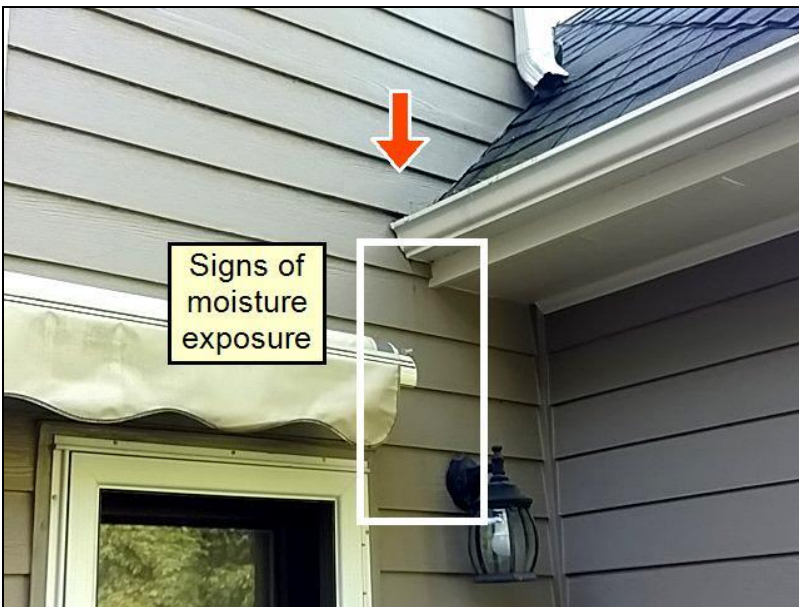
Rear left

3.9 (3) Missing kick-out flashing noted at roof-to-wall intersections. NOTE: Kick-out flashing should be installed at wall-to-roof intersection to direct rain run-off away from exterior. Recommend upgrade.

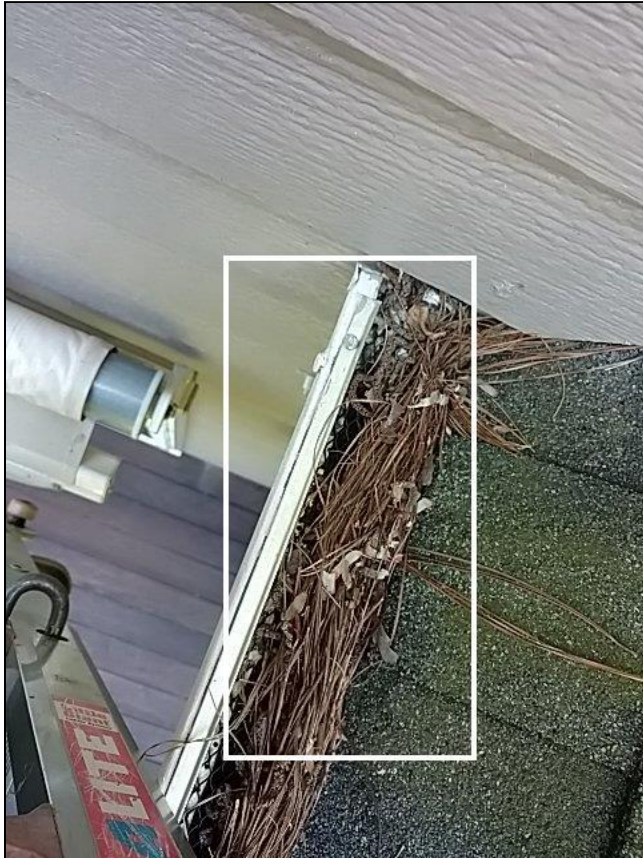
Rear left

3.9 (4) Covered gutter solution noted at numerous gutters. NOTE: Covers tend to hold/accumulate leaves/needles. Recommend frequent/as necessary maintenance to avoid rain back-up.

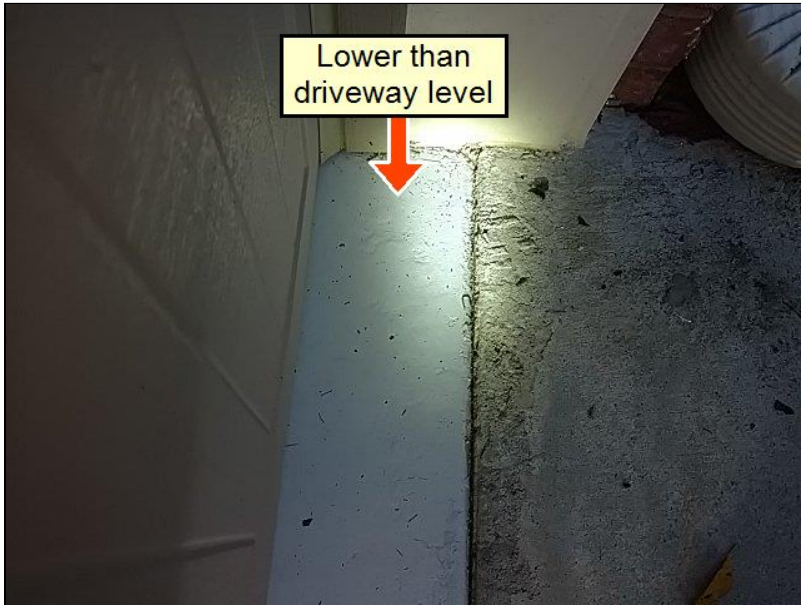
Front right

**4.2 (1) NOTE:** Garage floor at front right is below driveway grade and rain run-off could accumulate in this area. Monitor and adjust/repair as necessary.

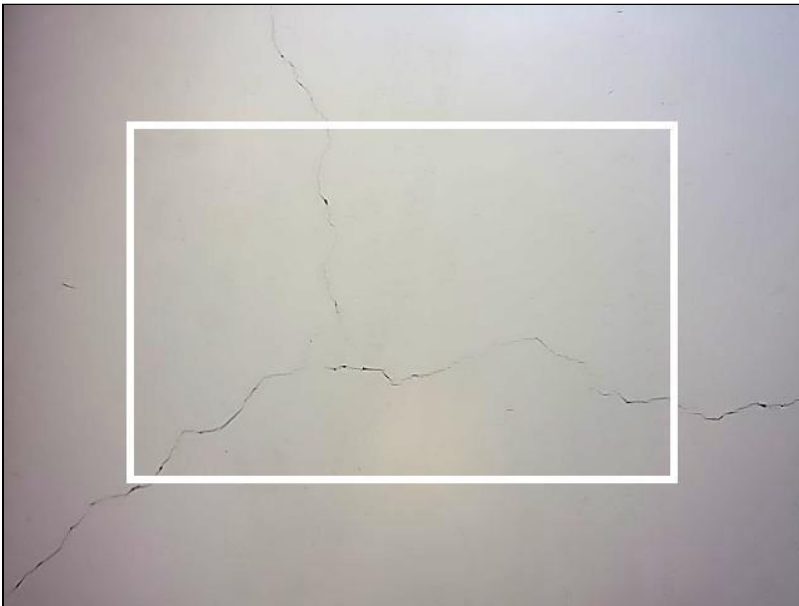
This location: Left

4.2 (2) Cracks noted at the garage floor. Monitor and repair as necessary.

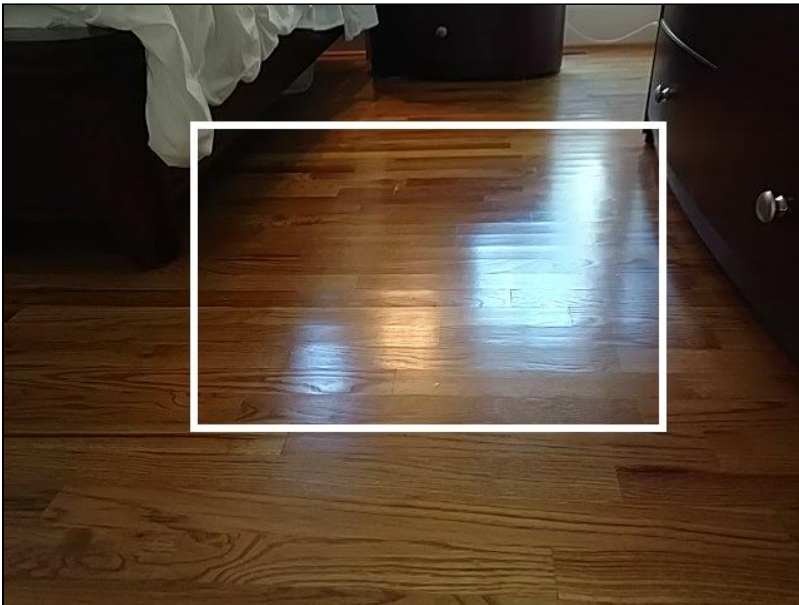
Master bedroom

**5.3** "Scalloping" noted at dining area and master bedroom flooring. NOTE: "Scalloping" indicates moisture content, possibly from high humidity. Monitor and repair/replace as necessary.

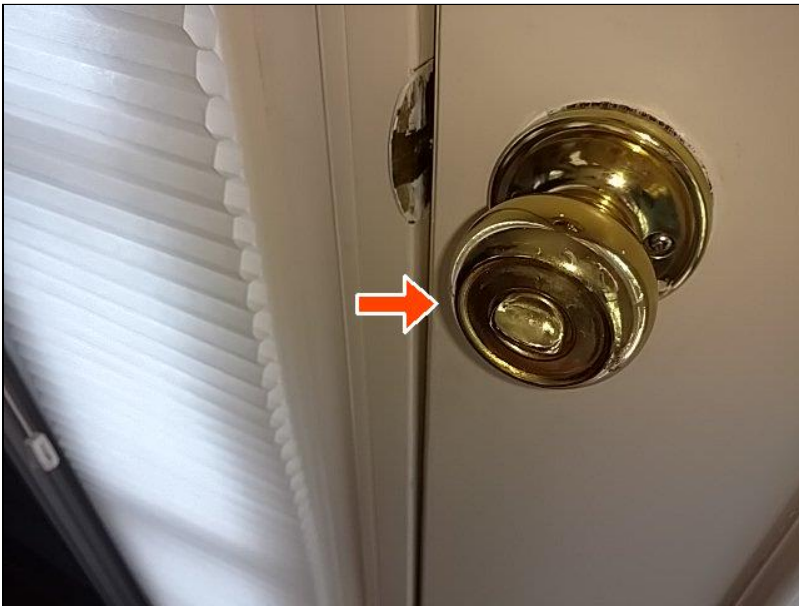
Sun room

5.5 (5) Door lock at sun room does not operate. Adjust/repair/replace as necessary.

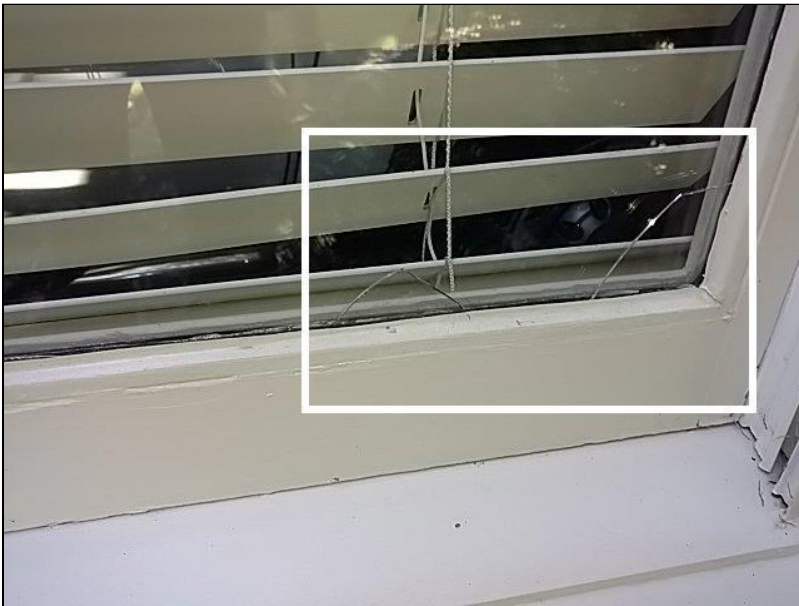
Garage, rear right

5.6 (1) Cracked pane noted at garage/rear right window. Replace pane.

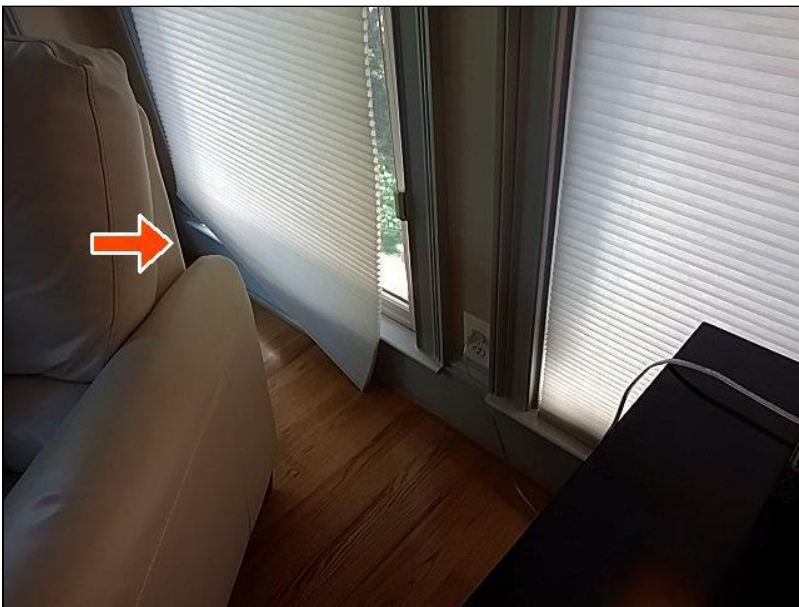
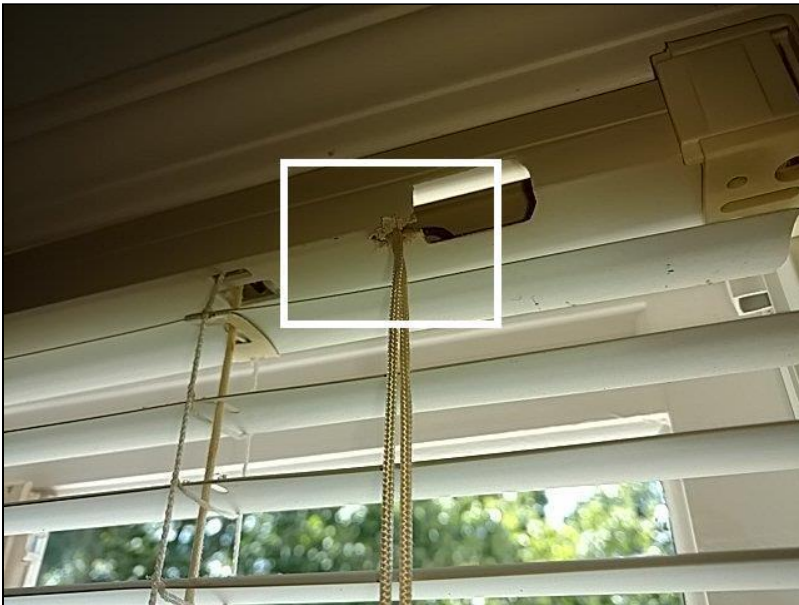
5.6 (2) Window treatment hardware not operating properly and observed at sun room right hand shades and bonus room closet. Repair/replace as necessary.

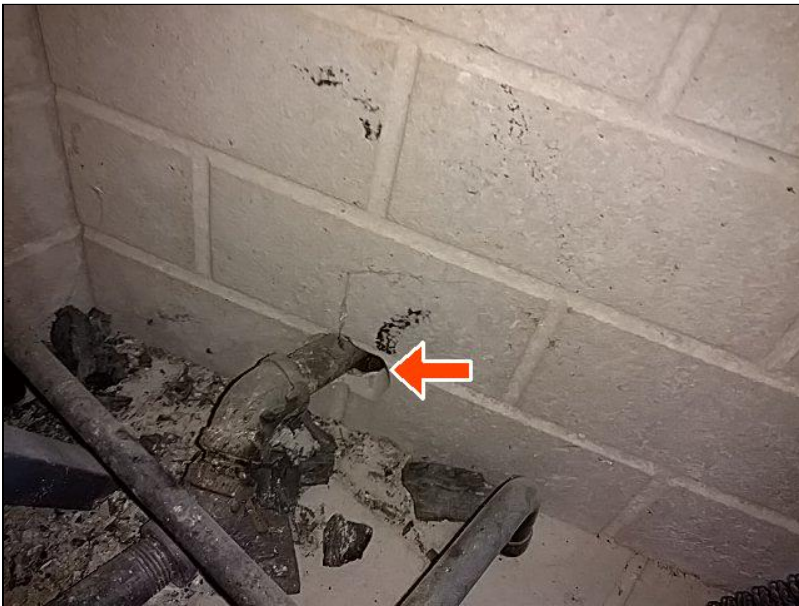
Living room fireplace

5.7 Missing seal noted at gas line penetration into the firebox at the fireplace. Seal penetration to improve fire safety.

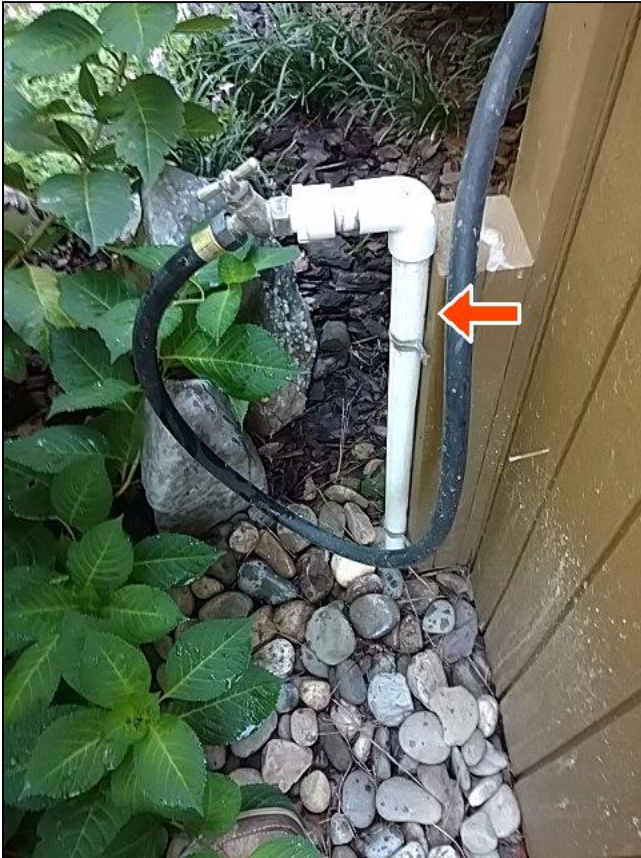
Rear

7.1 (1) Missing protection against freezing noted at rear water supply pipe. NOTE: Exposed water supply pipes should be protected against freezing. Repair as necessary.

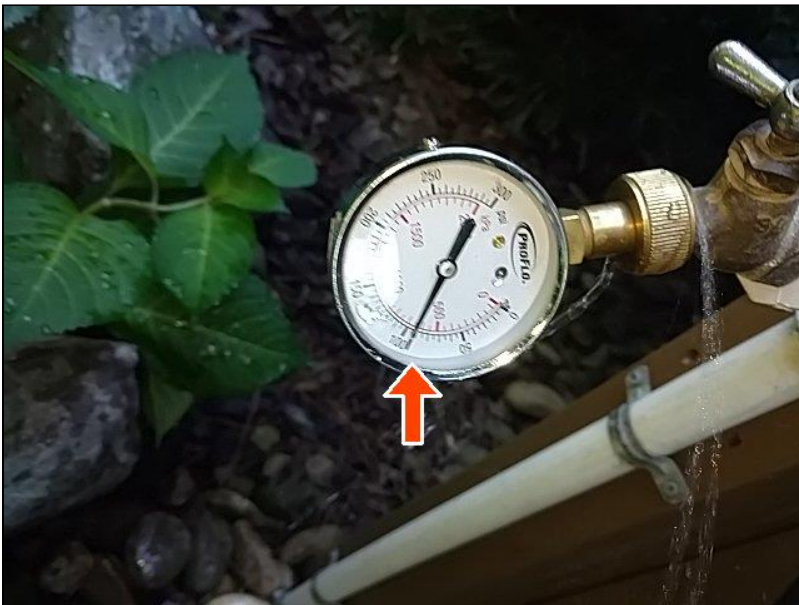
7.1 (2) High water pressure noted at rear exterior faucet (at deck). NOTE: Water pressure should not exceed 80 psi (between 40 and 80 psi). Adjust/replace pressure reduction valve as necessary to reduce water pressure below 80 psi to protect plumbing system.

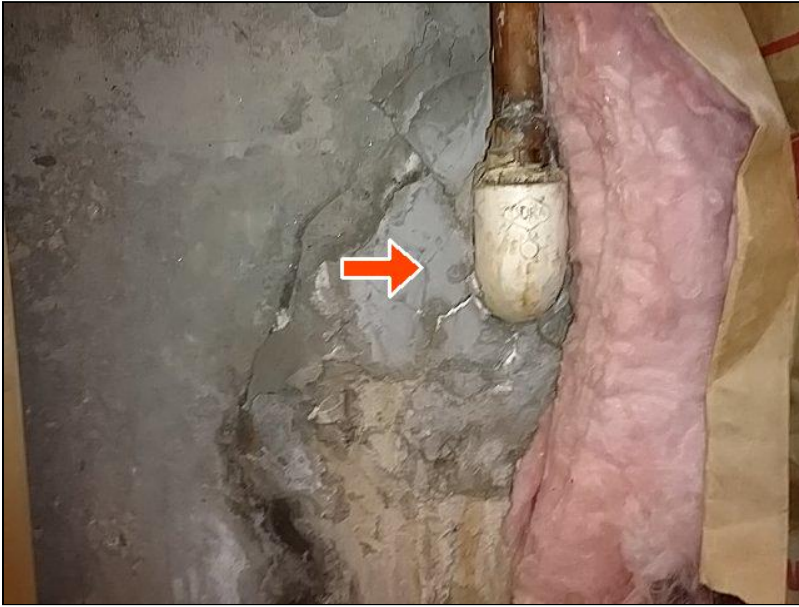
7.1 (3) Signs of prior moisture entry and repairs noted at the water main supply entry into the basement. Monitor and repair as necessary.

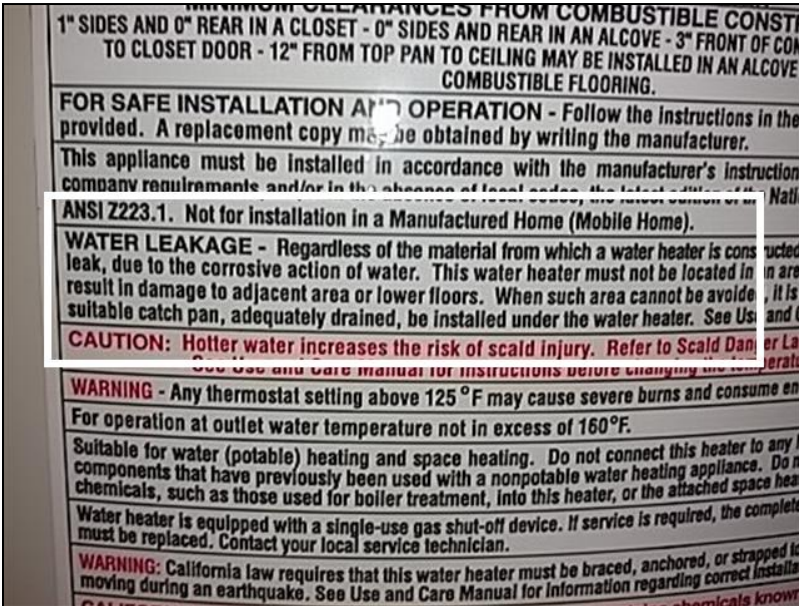
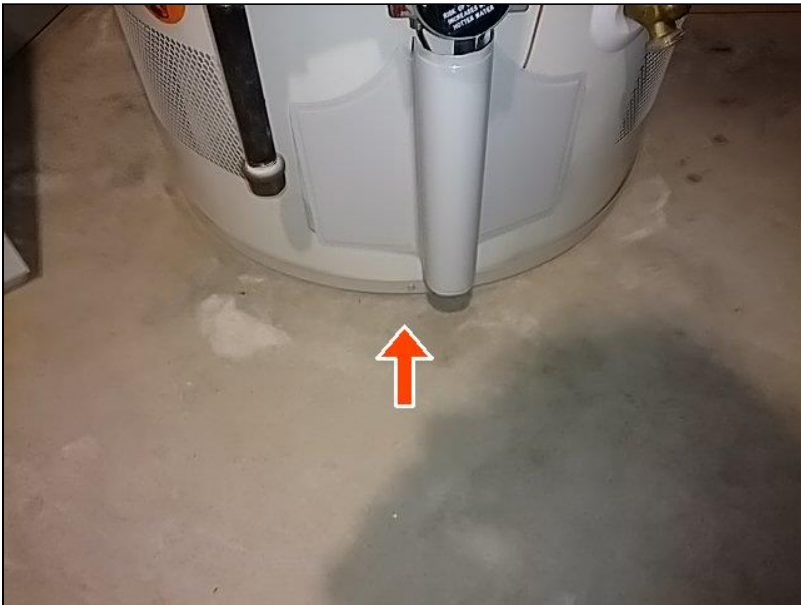
7.3 Missing drain pan noted at water heater. Recommend to install a drain pan/catch pan with moisture sensor to minimize risk of flood damage. Refer to manufacturers guidelines.

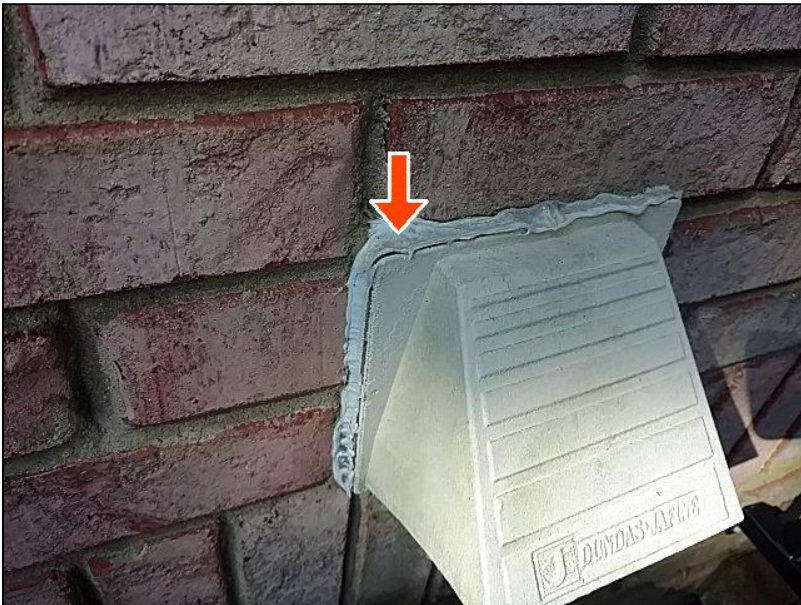
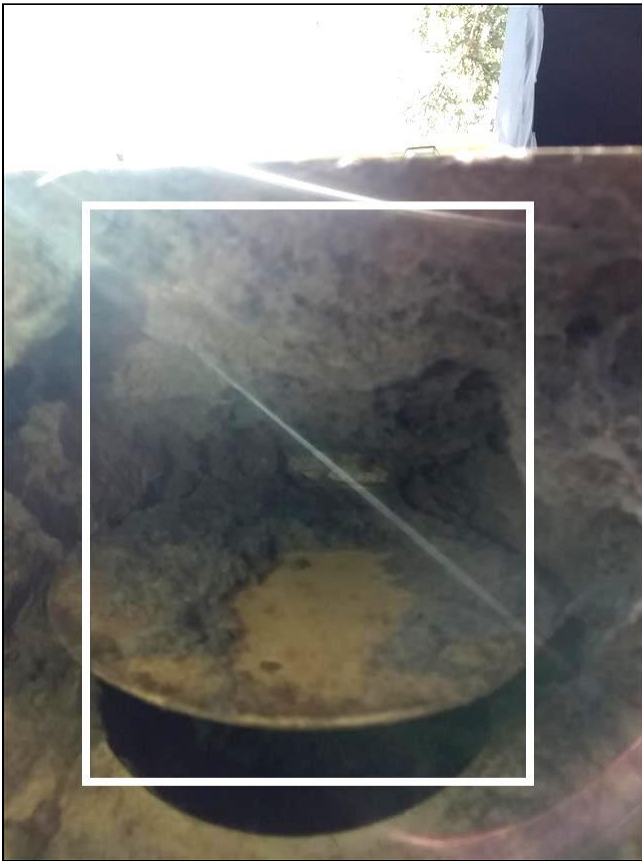
7.4 Loose dryer vent cover and lint accumulation noted at dryer vent. The backdraft flap does not close. Clean vent to avoid fire hazard and recommend to install a louvered cover.

Loose dryer vent

Lint accumulation

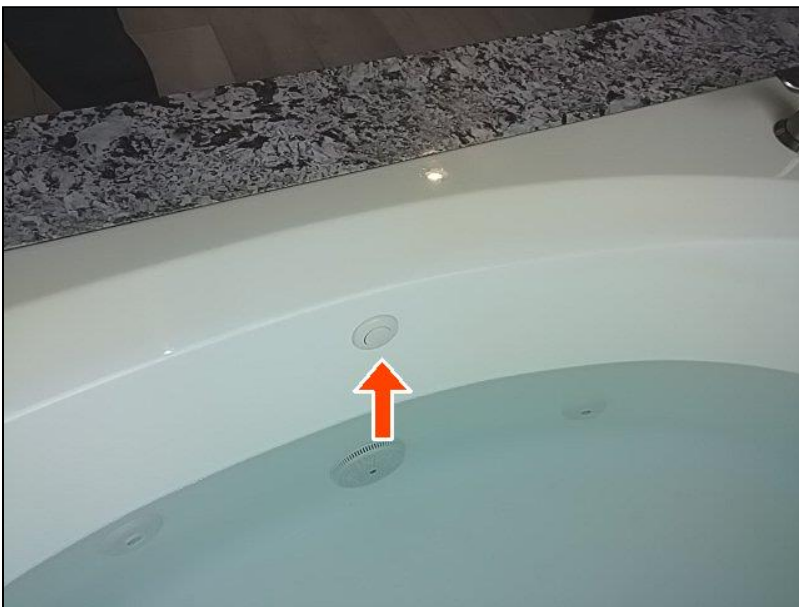
Master bathroom whirlpool tub

7.5 (1) The whirlpool function at the master bathroom tub did not operate. Recommend evaluation by a licensed plumbing contractor.
