**CHAMPIA**  
REAL ESTATE INSPECTIONS

## Inspection Report

<b>Date:</b> 8/6/2018	<b>Time:</b> 09:00:00 AM	<b>Report ID:</b> 32621 a
<b>Property:</b> [Redacted]	<b>Customer:</b> [Redacted]	<b>Real Estate Professional:</b> [Redacted]

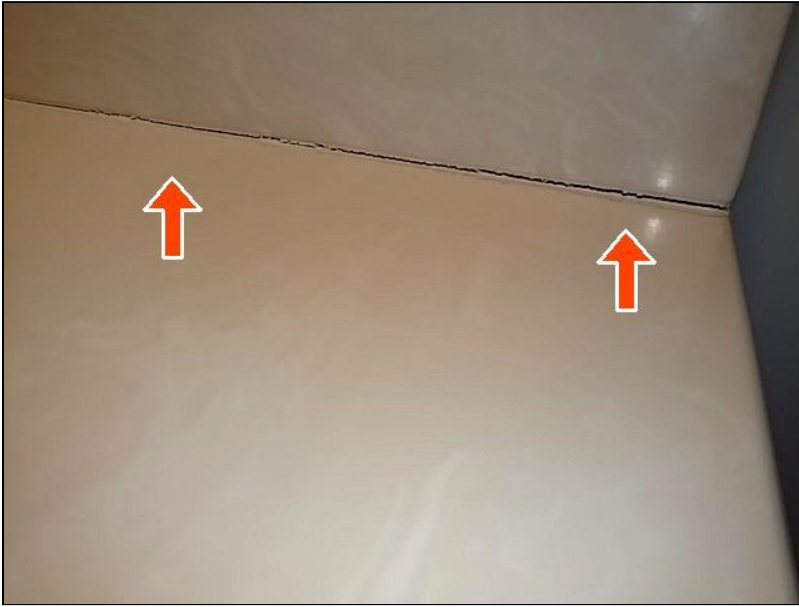
7.5 (2) Separation noted at numerous back-splash panels and observed at 2nd floor shared bathroom sink area(s). Seal as necessary.

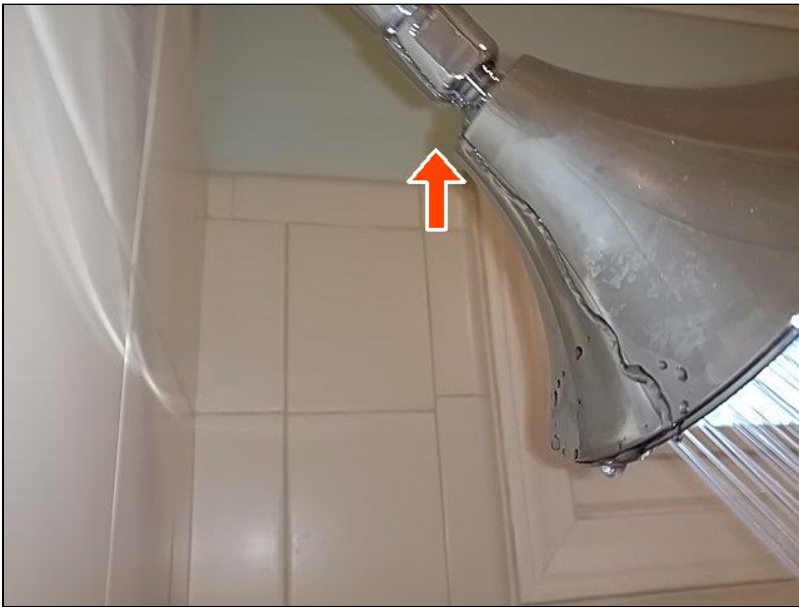
2nd floor shared bathroom

7.5 (3) Leak noted at 2nd floor hall bathroom bathtub/shower head. Repair/replace as necessary.

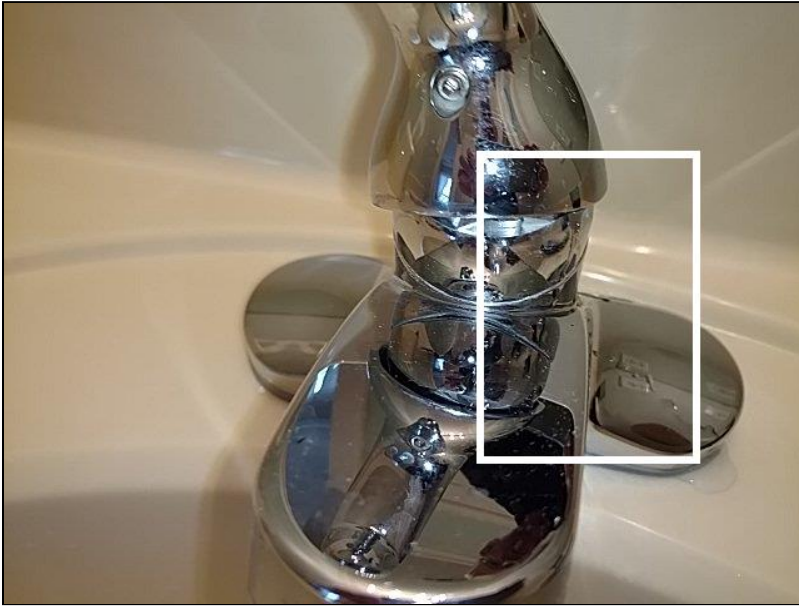
2nd floor shared bathroom, left sink

**7.5 (4) Leak noted at 2nd floor shared bathroom at left sink faucet. Recommend further evaluation by a licensed plumbing contractor.**

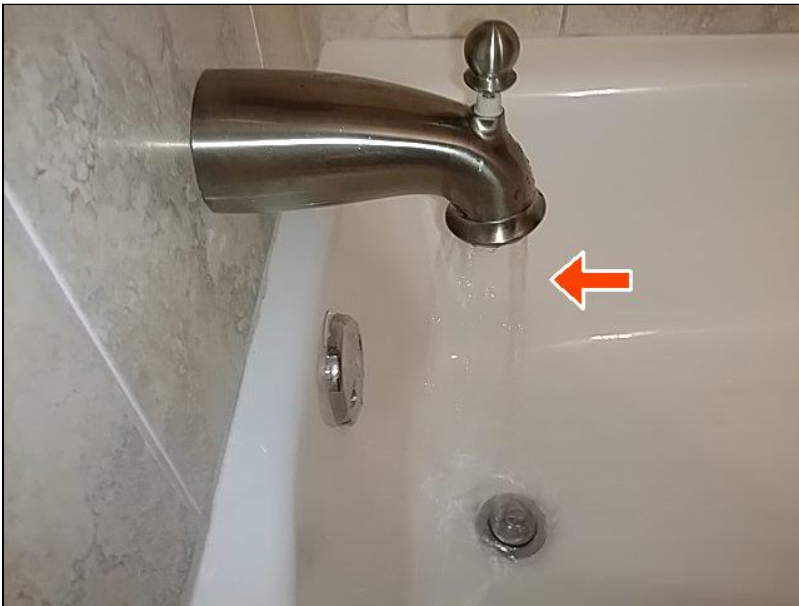
Basement

7.5 (6) Diverter at basement bathroom did not seal properly (when set to shower operation). Adjust/repair as necessary.

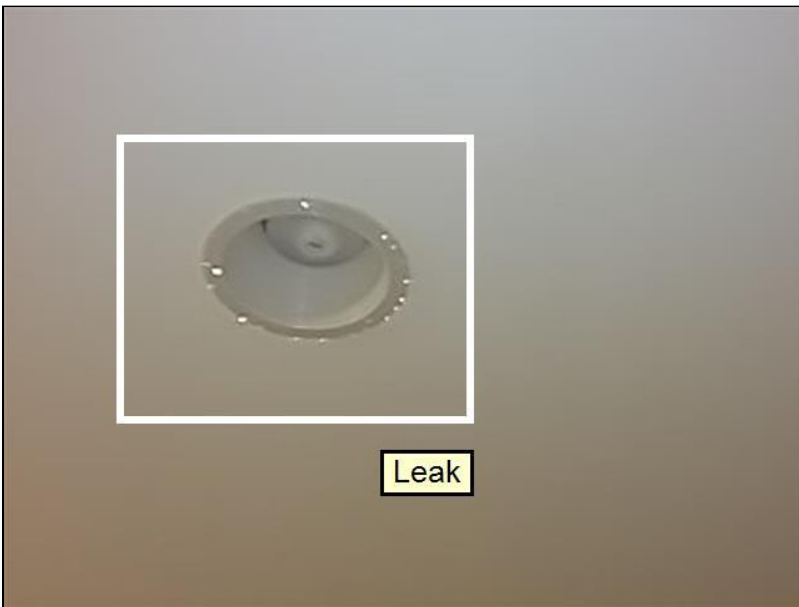
Rear left basement

7.5 (7) **Leak noted at rear left basement, presumably originating from the master bathroom shower or whirlpool tub. Consult with a licensed plumbing contractor for further evaluation.**

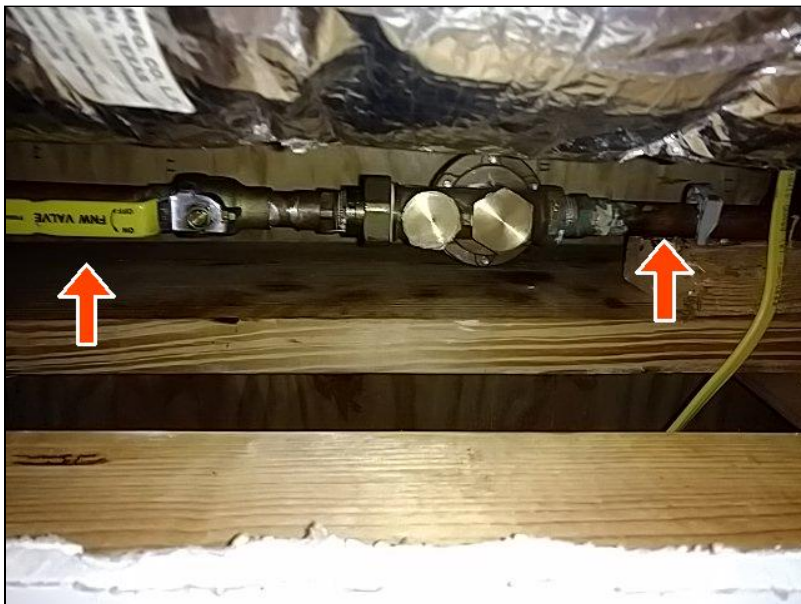
Pressure reduction valve

**8.1** Missing bonding jumper noted to bypass equipment in-line at copper water lines (i.e. pressure reduction valve) or to connect hot/cold water lines. Install bonding jumper(s) as necessary to include copper water lines into the grounding system.

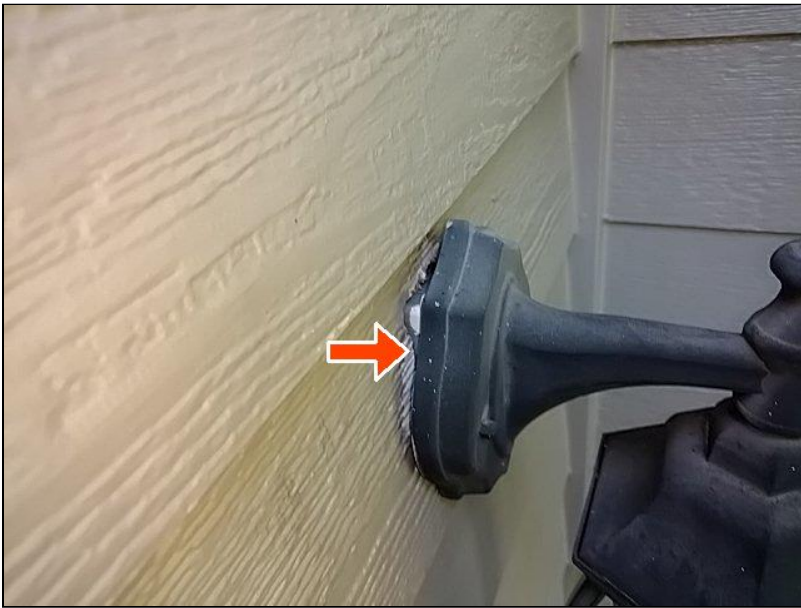
Rear left

8.3 (1) Loose fixture noted at rear left exterior (deck). Adjust fixture/seal as necessary to avoid moisture entry.

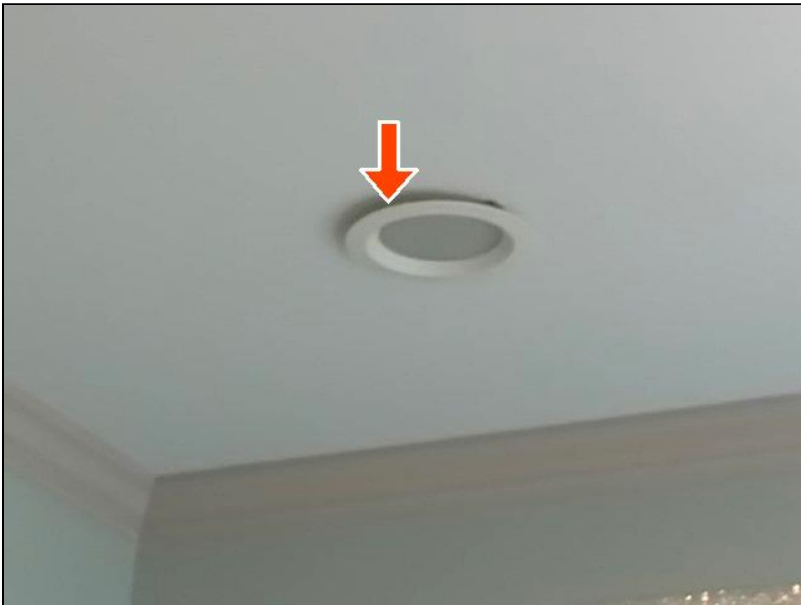
Master bathroom shower

8.3 (2) Separated light fixture noted at master bathroom shower. Adjust as necessary.

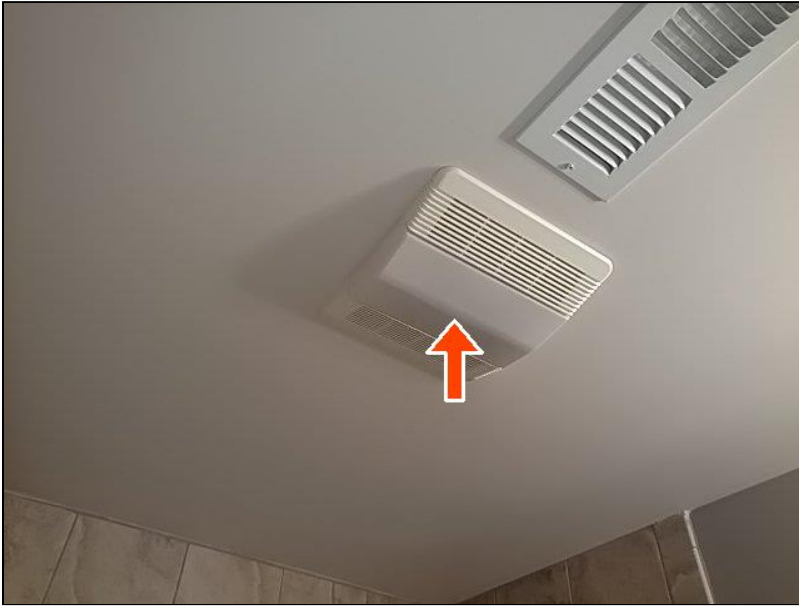
Basement bathroom

8.3 (3) Light fixtures at numerous locations did not operate and observed at the basement bathroom fan/light and rear basement light fixtures. Check light bulbs/evaluate circuits. Replace/repair where necessary.

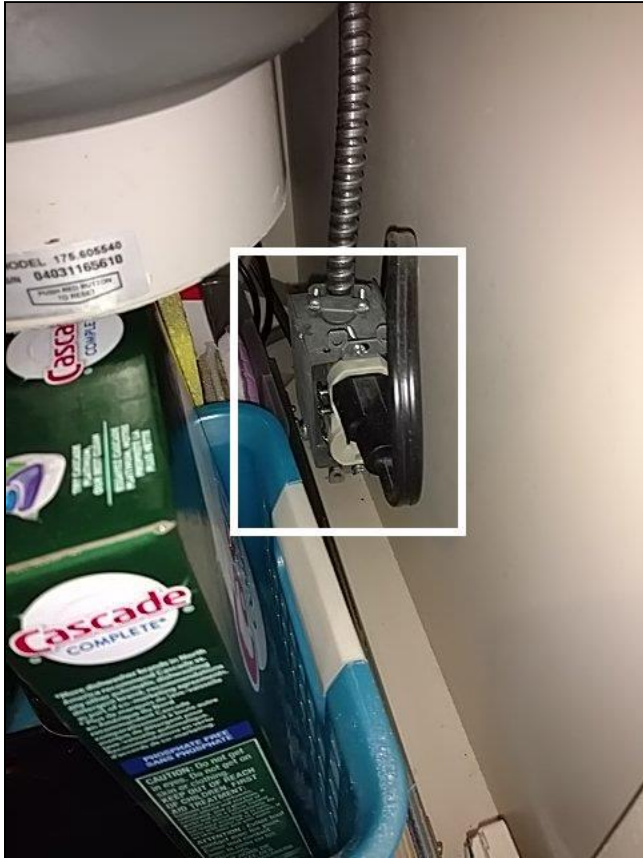
Kitchen sink cabinet

8.4 Missing cover noted at receptacle in the kitchen sink cabinet. NOTE: Junction, switch and receptacle boxes should be covered. Install covers as necessary.

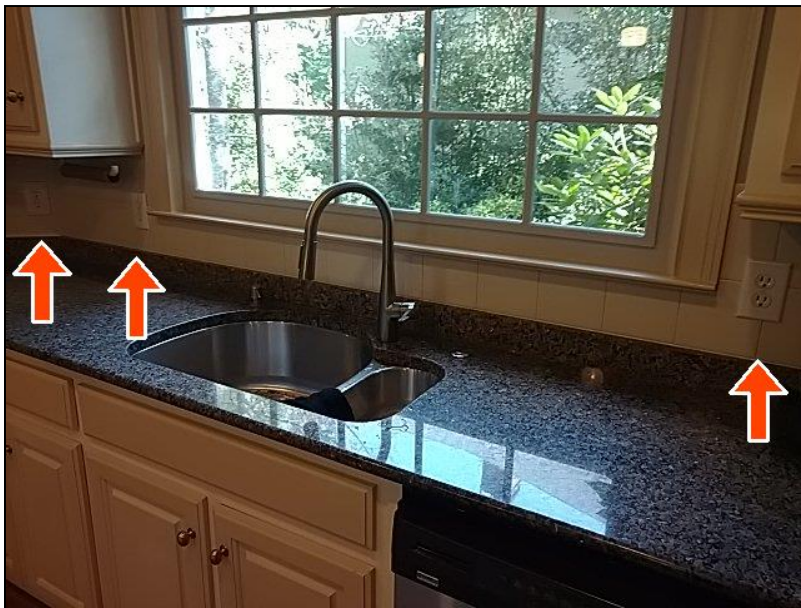
Kitchen counters

8.5 (1) Missing GFCI (and AFCI) protection noted at kitchen receptacles (counter, island and under-sink). Recommend to install GFCI (and AFCI) protection at noted locations.

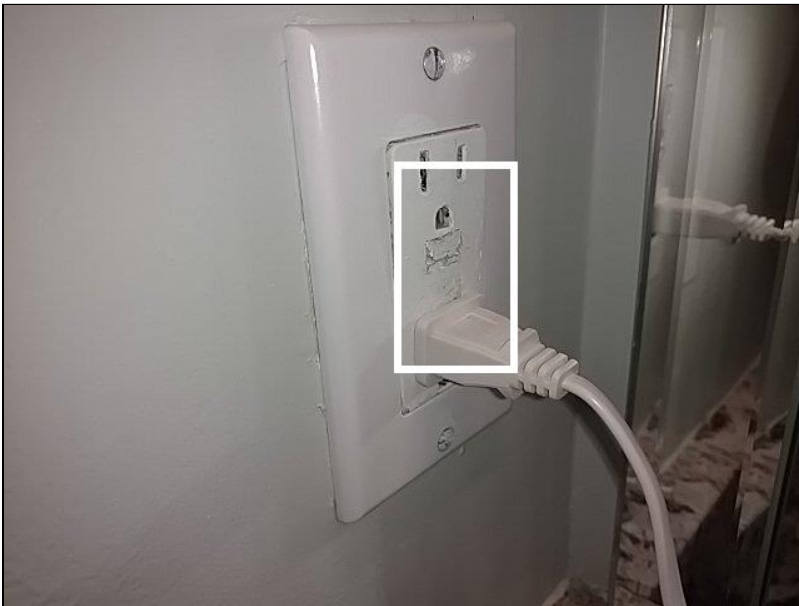
Master bathroom

8.5 (2) The GFCI receptacle in the master bathroom was found painted over. Recommend replacement.

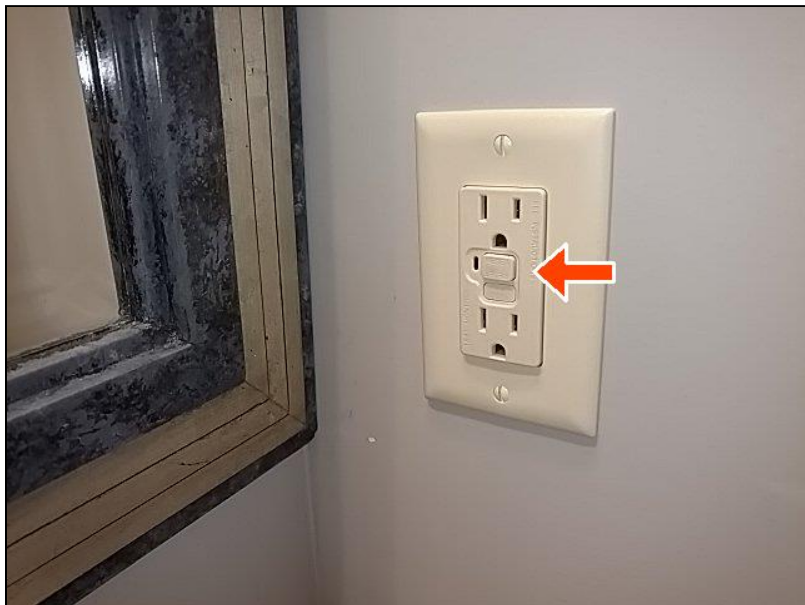
Basement bathroom

8.5 (3) The GFCI receptacle in the basement bathroom did not reset. Recommend evaluation of the receptacle, wiring, breaker (as necessary) by a licensed electrical contractor.

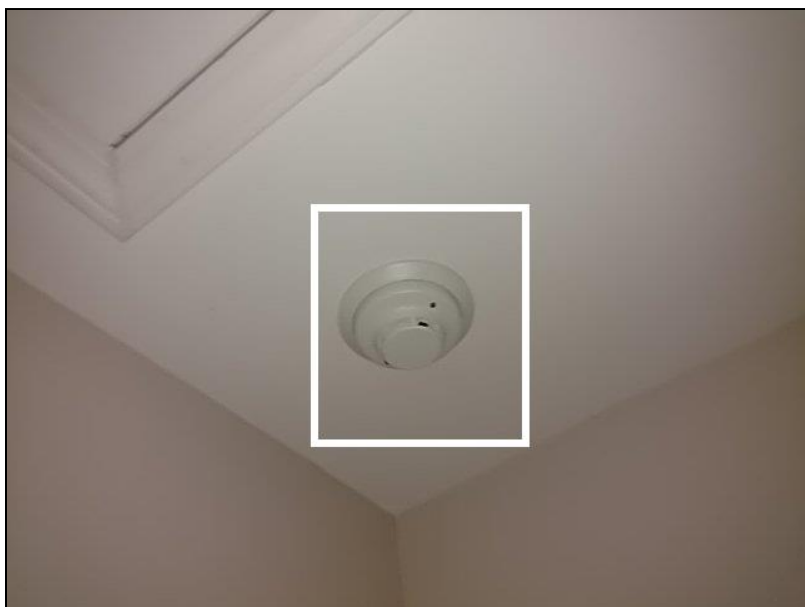
8.7 NOTE: The smoke and carbon monoxide detectors appear to be monitored remotely (some locations). Unable to test functions. Recommend to consult with owner for clarification.

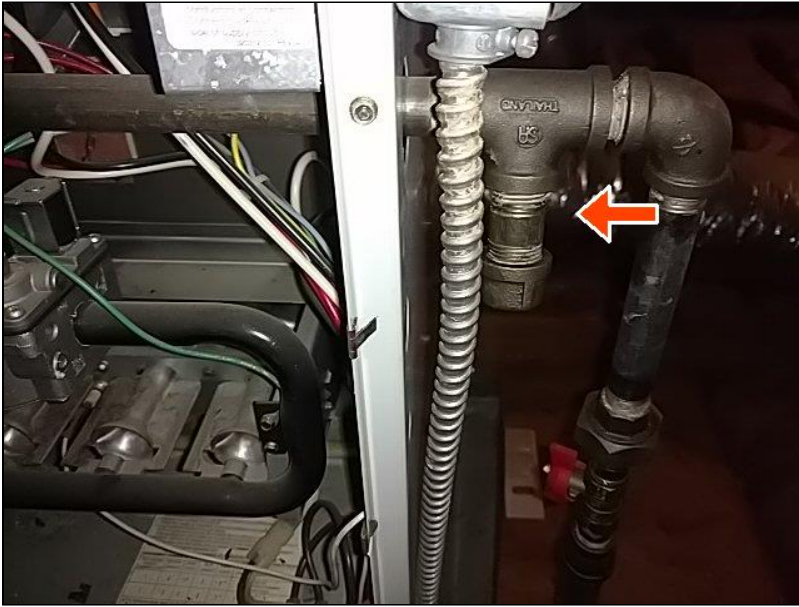
9.0 (2) Improper installation of sediment trap noted at 2nd floor furnace gas supply. NOTE: The sediment trap has to be installed at a turn of the gas supply to work as intended. Repair as necessary. Refer to attached illustration for acceptable sediment trap configuration.

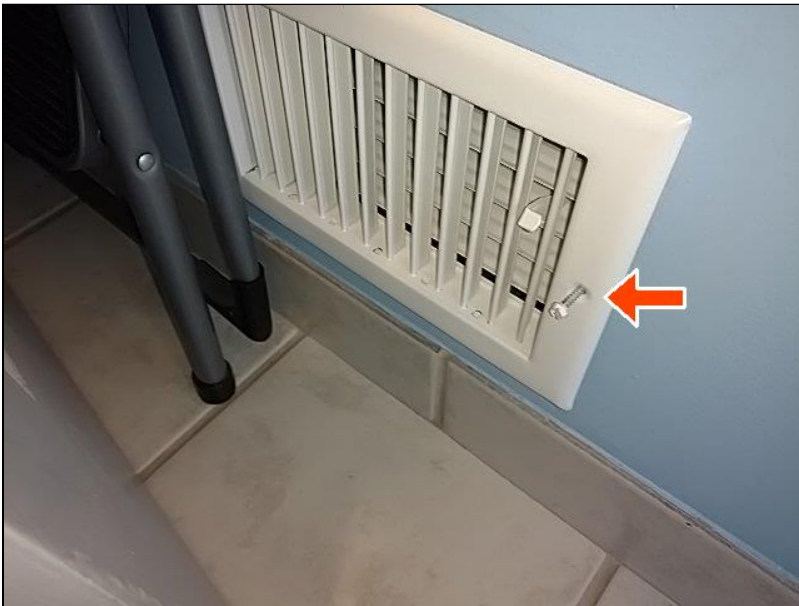
Laundry

9.3 (1) Duct cover in the laundry is not secure. Repair as necessary.

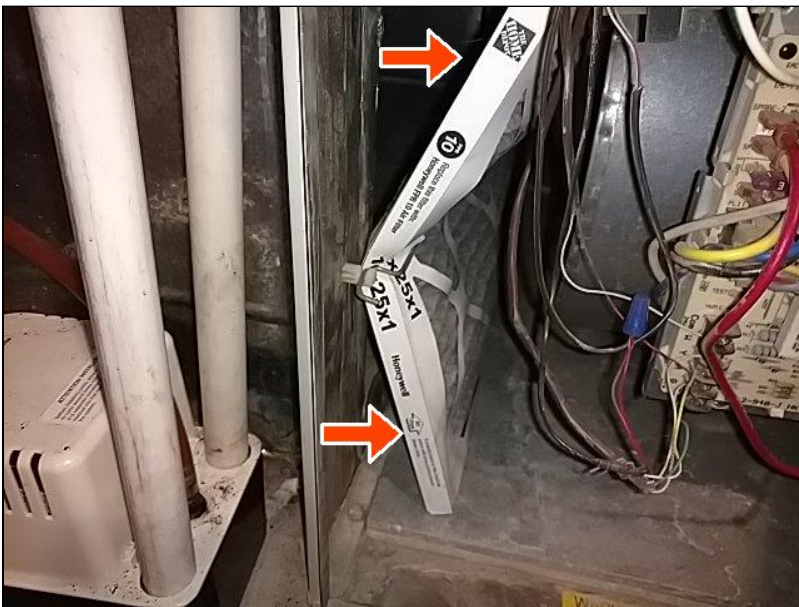
9.3 (2) The filter in the 1st floor return plenum was found bend (bending during operation). Recommend to install a retainer to keep the filter straight and improve air filtration.

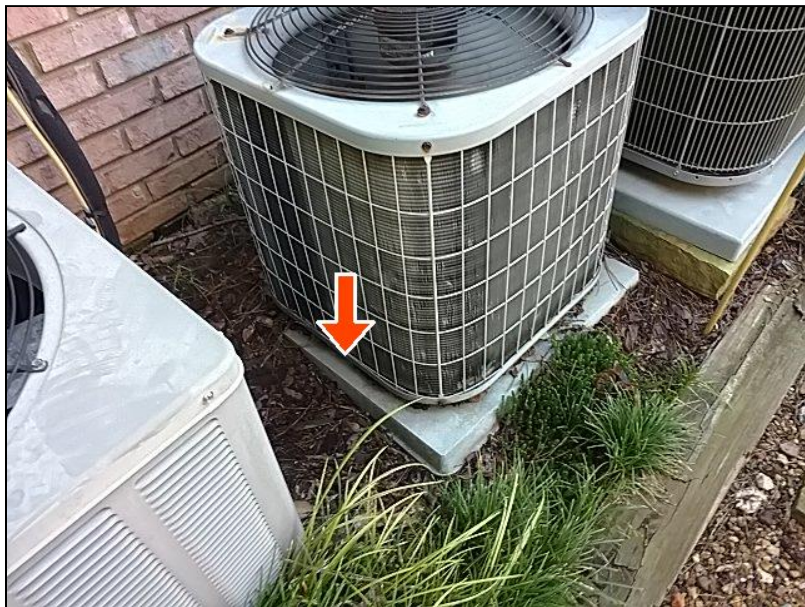
9.4 (1) The condenser pad for the 2nd floor condenser is not level. NOTE: Typically a level pad is required for condensers. Recommend to refer to (condenser) manufacturers installation guidelines and repairs if necessary.

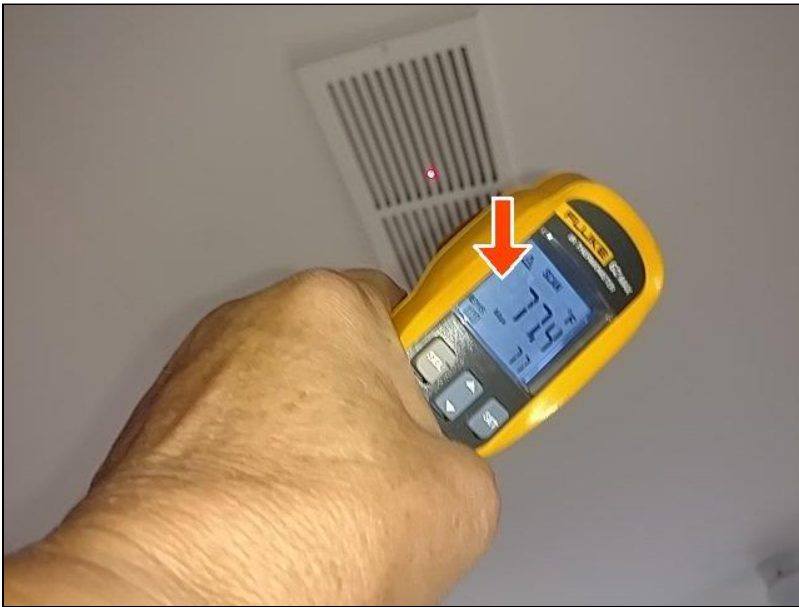
2nd floor, return

**9.4 (3) Inadequate cooling noted at 2nd floor and basement. NOTE: A temperature difference of 15 F between return and supply is desired. The actual measured temperature was appr. 6 F (2nd floor), resp. 8 F (basement). Recommend further evaluation/service by a licensed HVAC contractor.**

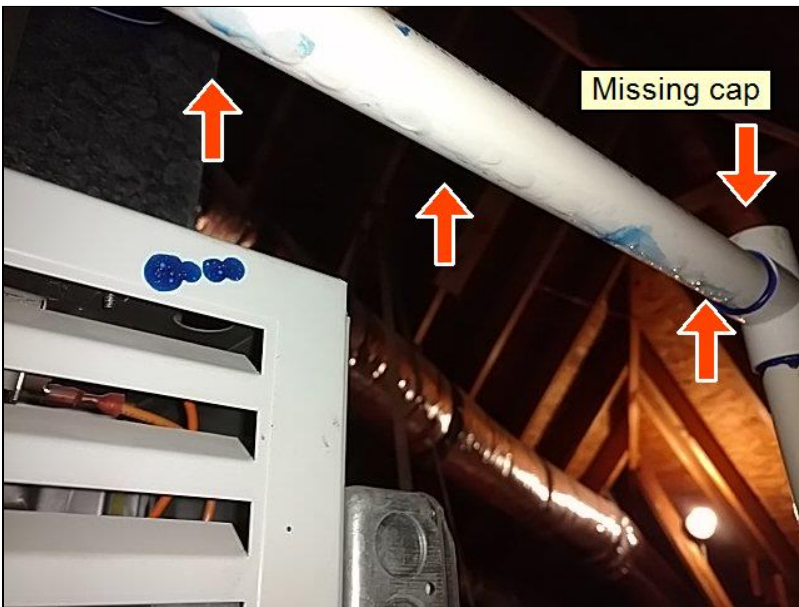
9.4 (4) Dripping condensate noted at 2nd floor condensate drain. Recommend to install insulation to avoid moisture dripping.

ALSO: Missing cap noted at the drain line turn-of-direction. Install (removable) cap to improve efficiency

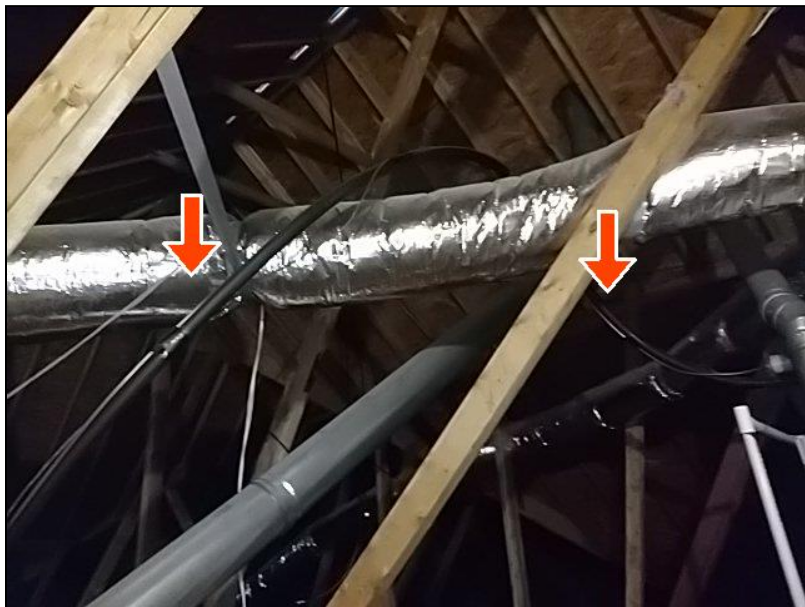
2nd floor line set

9.4 (5) Line set not secured. Noted at 2nd floor. NOTE: Typically line sets are secured every 6 ft. Refer to manufacturers guidelines and repair as necessary.

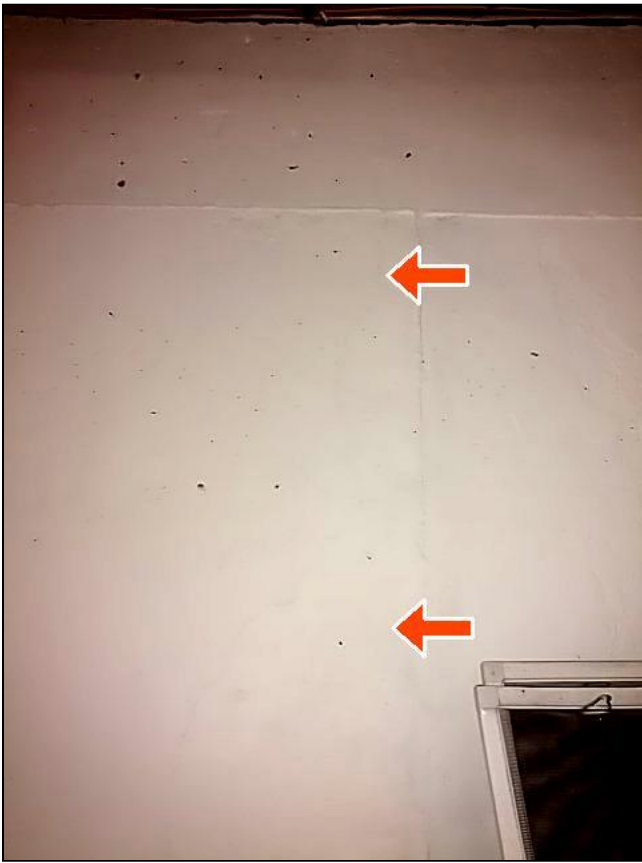
Front basement wall

10.1 Crack noted at front basement foundation wall. Observe and repair as necessary.

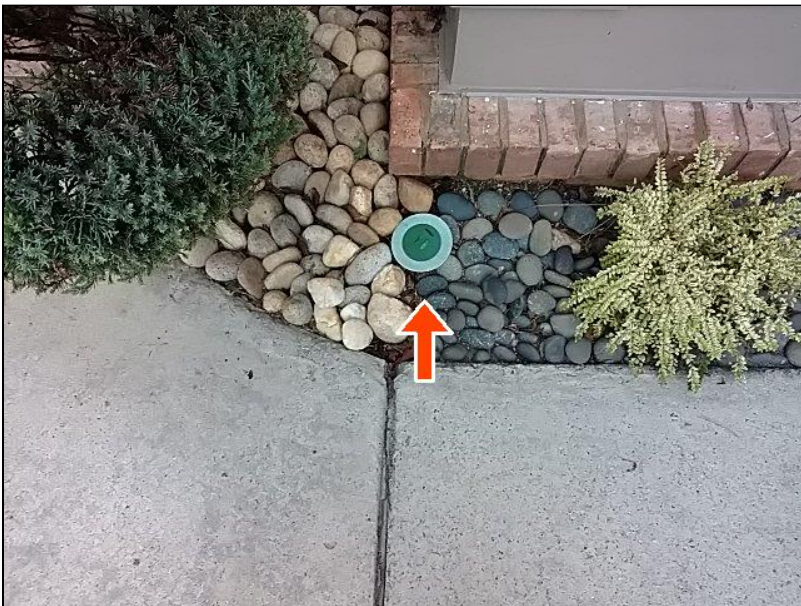
10.4 Treatment against wood destroying organisms noted. Recommend to consult with owner about termite bond or obtain from a licensed pest control contractor.
