**CHAMPIA**  
REAL ESTATE INSPECTIONS

## Inspection Report

<b>Date:</b> 8/6/2018	<b>Time:</b> 09:00:00 AM	<b>Report ID:</b> 32621 a
<b>Property:</b> [Redacted]	<b>Customer:</b> [Redacted]	<b>Real Estate Professional:</b> [Redacted]

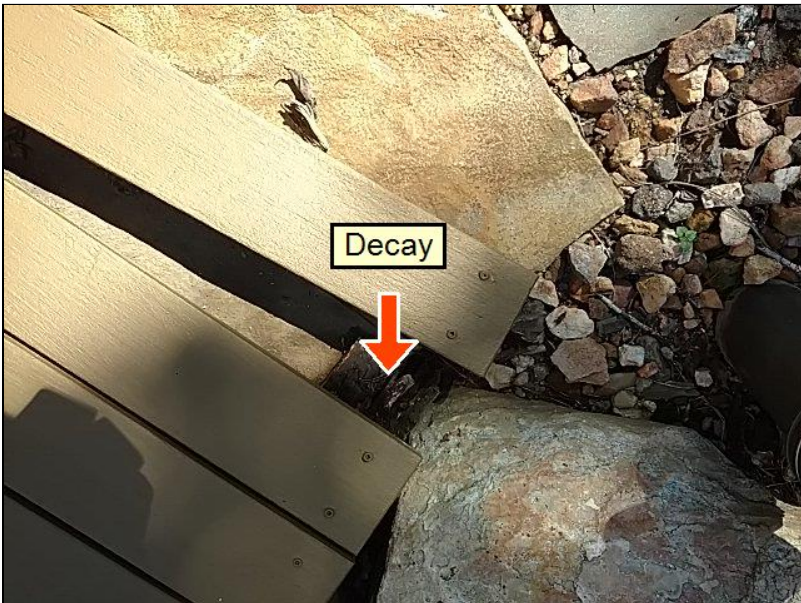
Front left

**1.0** Loose board and decay noted at front left decorative bridge structure. Repair/replace as necessary.

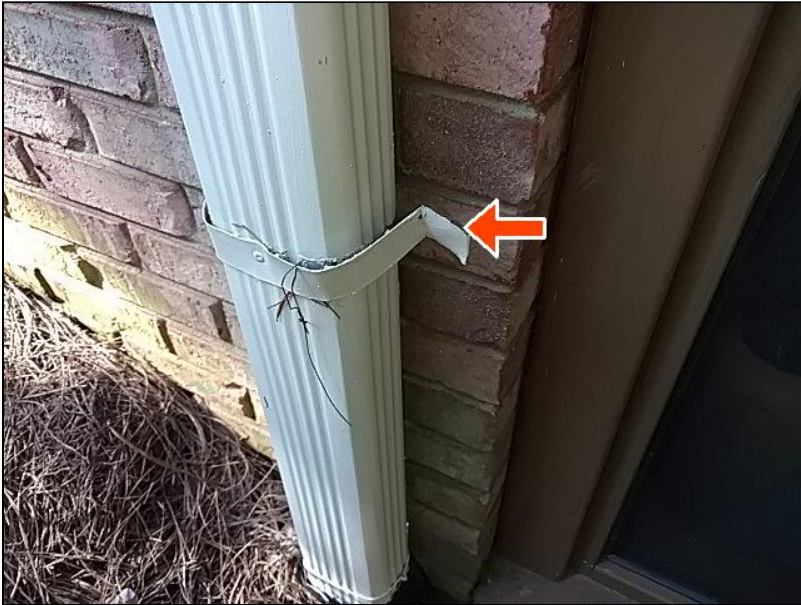
Rear right

- (1) Loose downspouts noted at rear left, right and center. Repair as necessary.
- (2) Downspout extension at rear center terminated in front of deck support column. Recommend to re-direct extension to avoid erosion/weakening of soil.

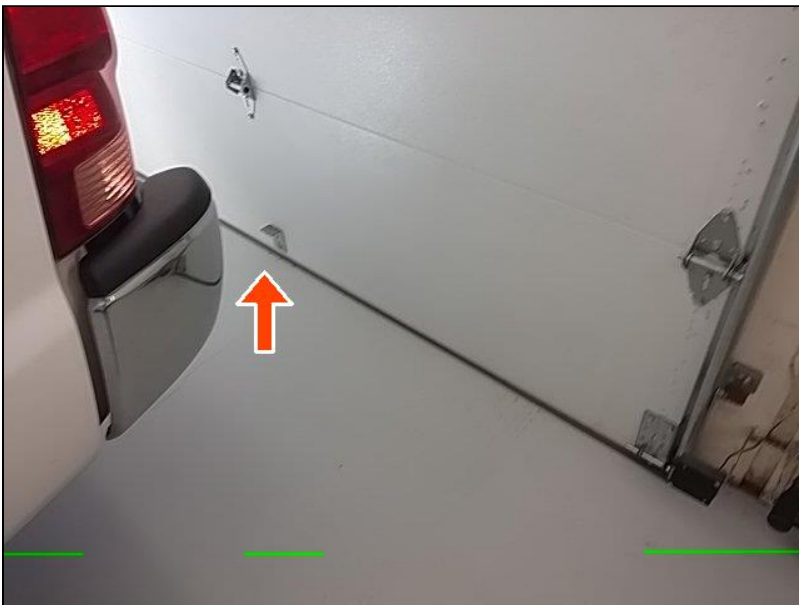
Right

4.4 The right hand garage door did not reverse when met with resistance. Adjust lift motor as necessary.

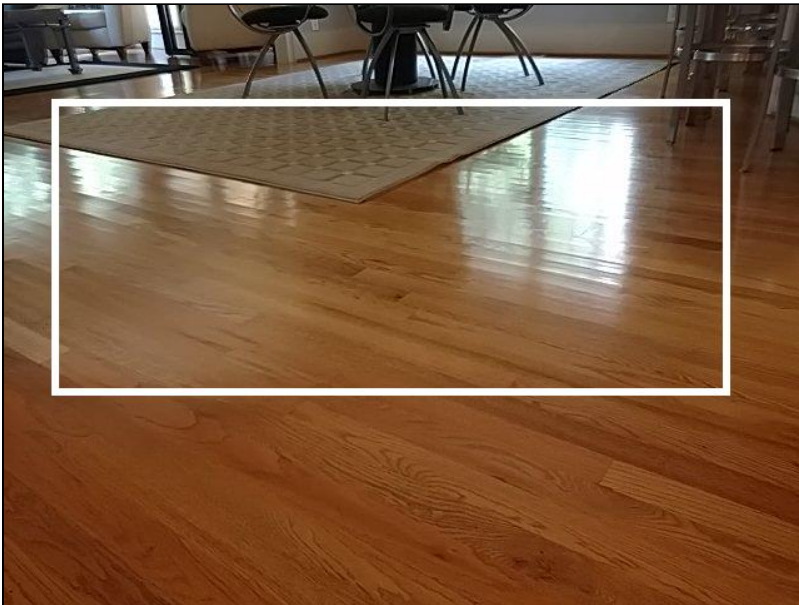
Dining room

**5.3** "Scalloping" noted at dining area and master bedroom flooring. NOTE: "Scalloping" indicates moisture content, possibly from high humidity. Monitor and repair/replace as necessary.

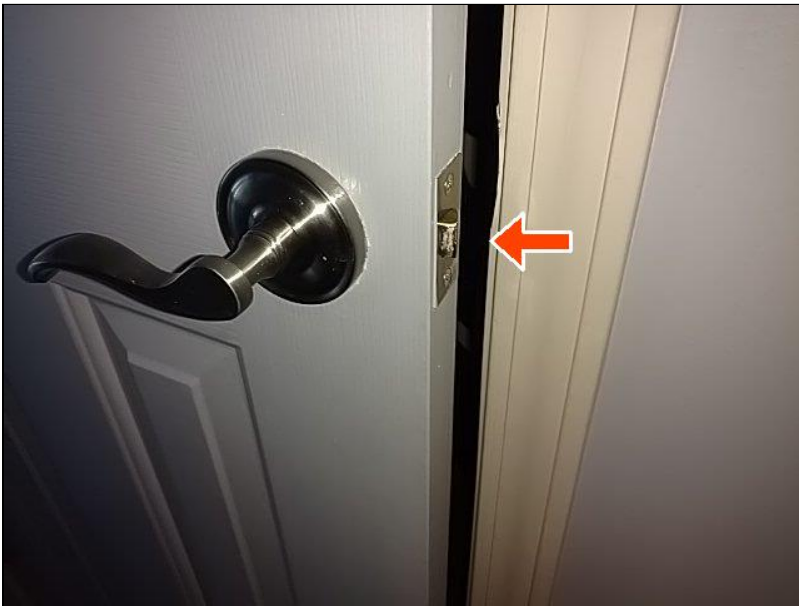
Pantry

5.5 (1) Door at pantry does not latch. Adjust as necessary.

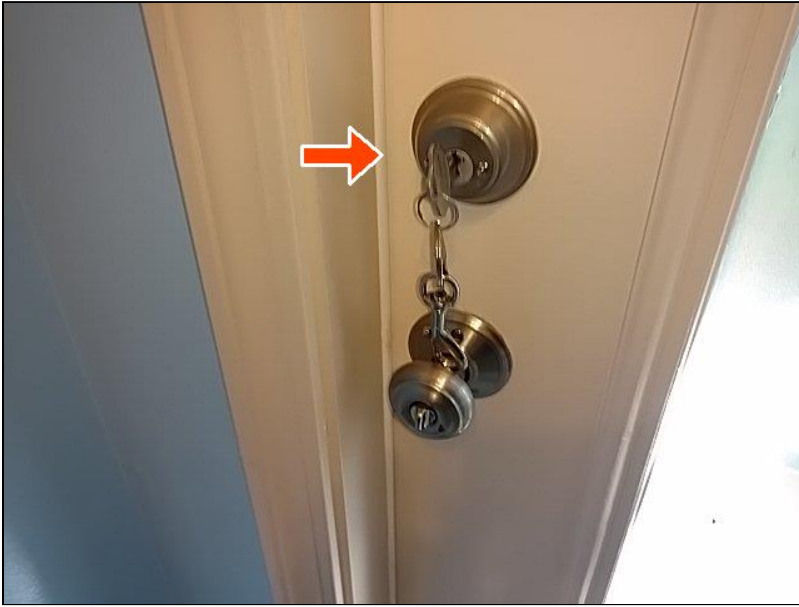
Laundry

5.5 (2) Exterior doors are keyed. NOTE: Egress doors should not be keyed at the interior to allow for opening of the door(s) without a key in case of emergency. Install dead bolts with thumb latch.

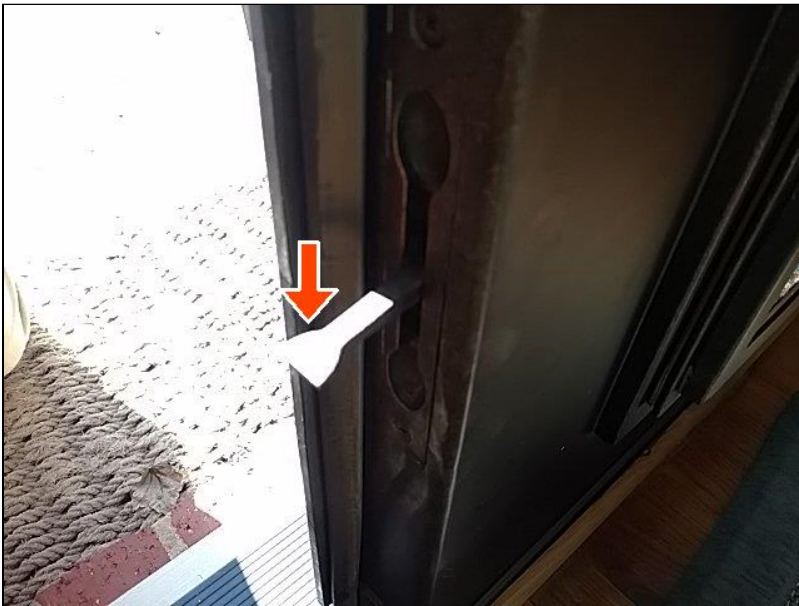
Front door

5.5 (3) Lower door lock at right hand (stationary) panel of the front door does not lock. Adjust as necessary.

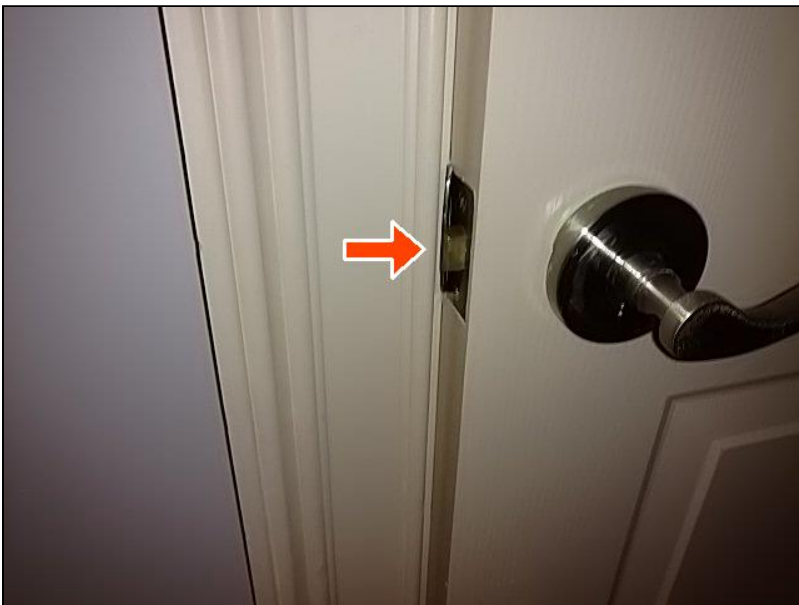
Rear left basement

5.5 (4) Doors at rear left basement and wine cellar do not latch/door panels bind. Adjust as necessary.

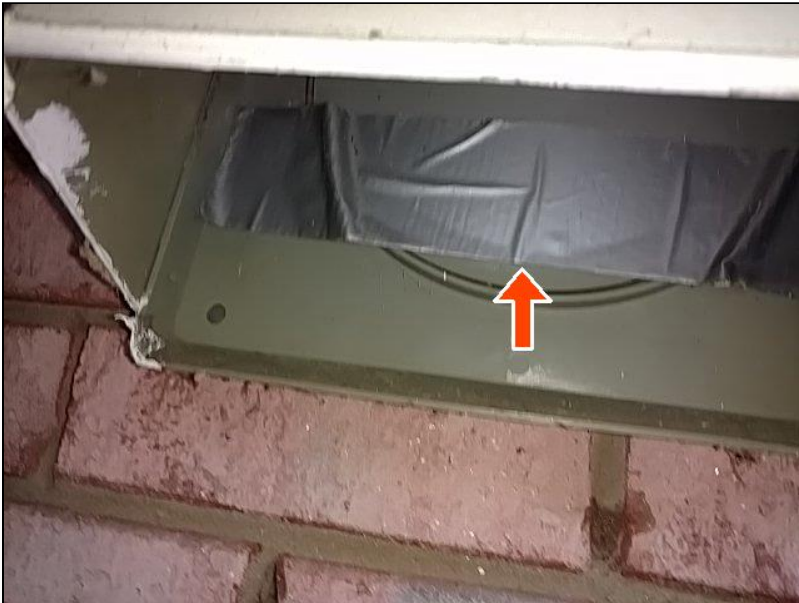
Kitchen vent was sealed at the exterior and is apparently not in use. NOTE: An alternate source of cook top ventilation was not noted. Recommend to remove unused features and seal exterior as necessary.

**6.3** Kitchen vent was sealed at the exterior and is apparently not in use. NOTE: An alternate source of cook top ventilation was not noted. Recommend to remove unused features and seal exterior as necessary.

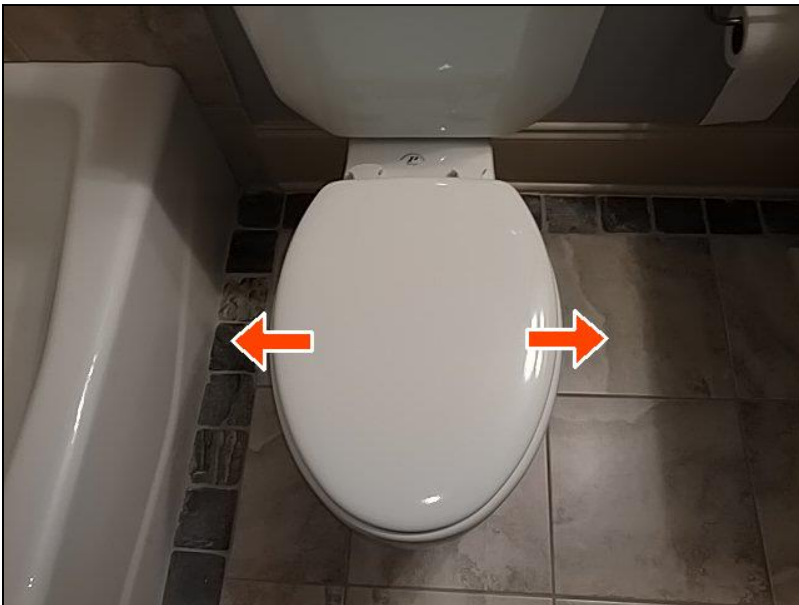
Basement

**7.5 (5) Loose toilet bowl noted at basement bathroom. Reset toilet bowl with approved sealing material (i.e. wax ring) and secure as necessary.**
